FEDERAL MINISTRY OF ENVIRONMENT
HYDROCARBON POLLUTION REMEDIATION
PROJECT
(HYPREP)

HYPREP ACTIVITIES
REPORT
AUGUST
2025

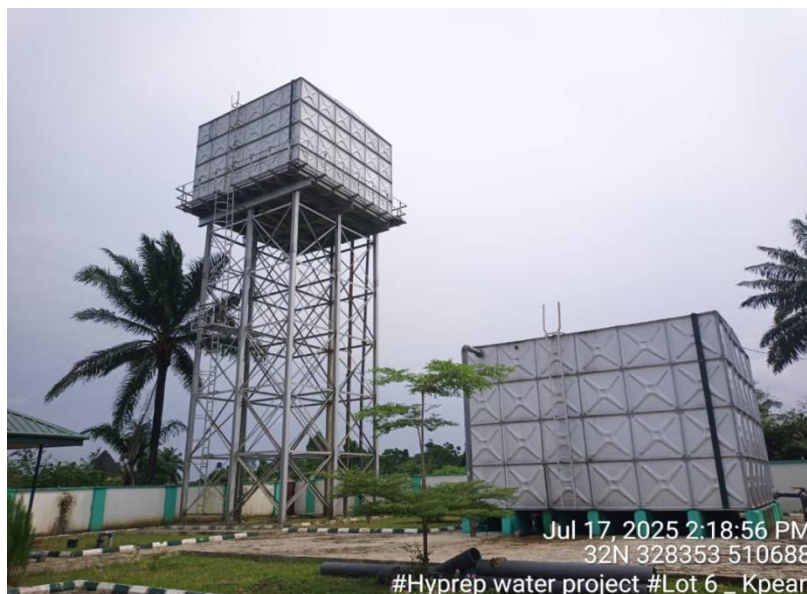
4.6 LOT 6: BORI/KPEAN/ZAAPON, KHANA LGA

The Kpean station is fully functional and supplying water to Kpean and Teenama communities. Variation approval is still on hold to allow completion of Bori headwork and Zaakpon booster station.

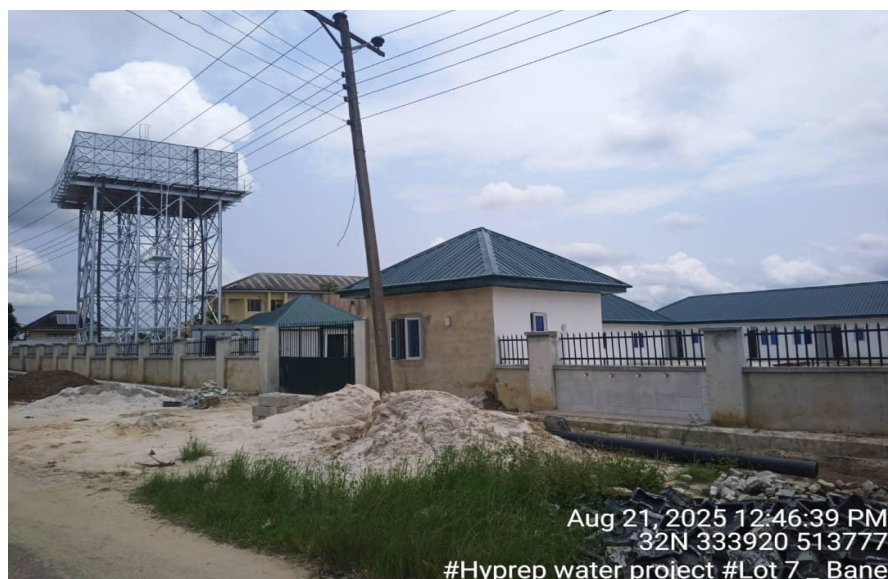
4.7 LOT 7: BUAN/BANE, KHANA LGA.

Activities at Lot 7 includes the construction of 2 headworks, 1 each at Buan and Bane communities respectively. General landscaping, painting, elevated and ground tank completion all ongoing at Bane.

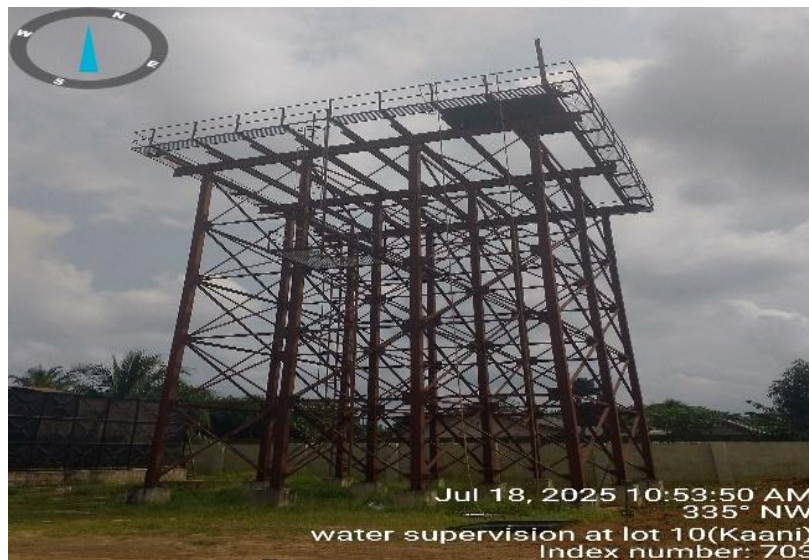
4.10 LOT 10: LUUSUE SOGHO/KAANI, KHANA LGA

Activities at Lot 10 cover the construction of 2 headworks, 1 each at Luusue Sogho and Kaani respectively. Installation of ground tank and elevated tank ongoing at Kaani.

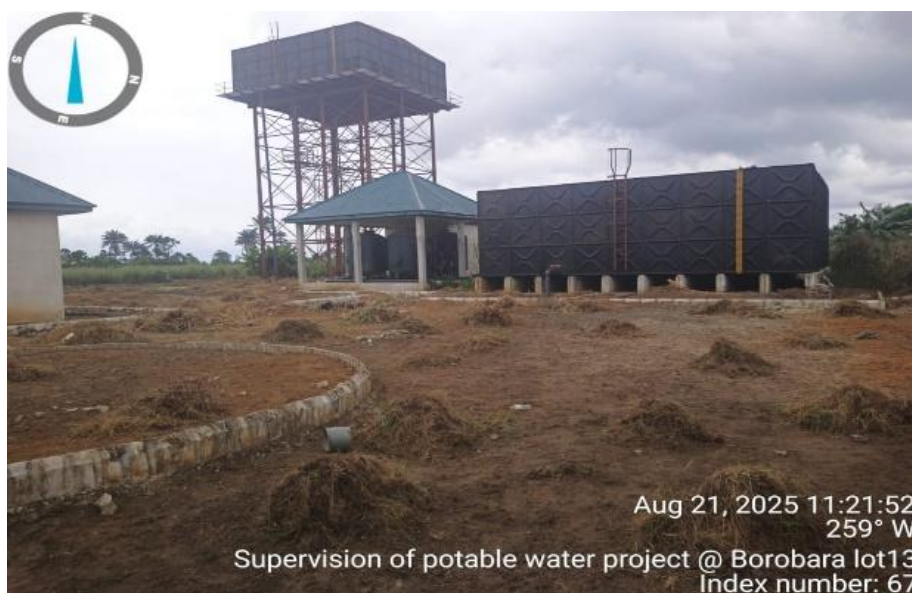
4.13 LOT 13: BOROBARA/KPORGOR, TAI LGA.

Activities at Lot 13 covers the construction of one headwork at Borobara. Construction of staff quarter, generator house, filter house, tanks and valve installation ongoing. At Kporghor, operation and maintenance is ongoing.

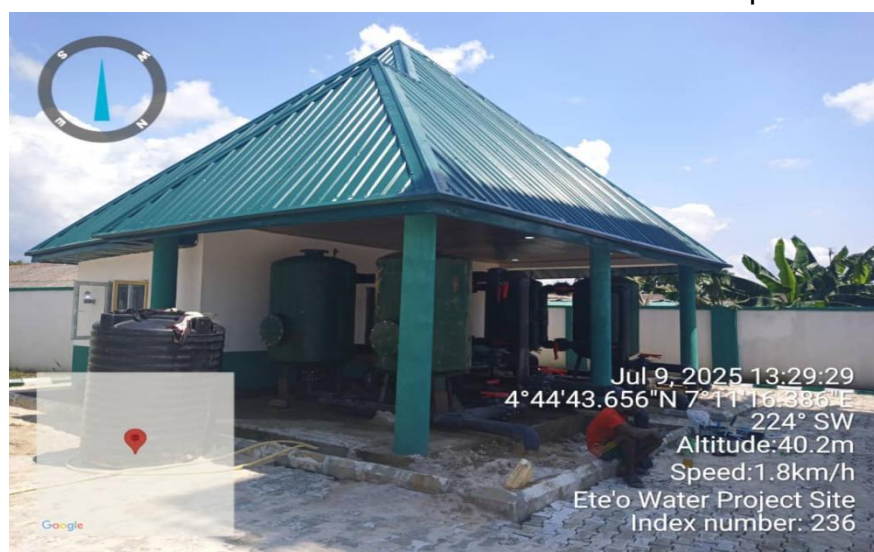
4.14 LOT 14: ETEO/ONNE, ELEME LGA.

Activities at Lot 14 cover the construction of 1 headwork each at Onne and Eteo communities respectively. Construction of ground and elevated tanks foundation at Onne, generator mobilised to Onne. The Eteo station is commissioned and on operational maintenance phase.

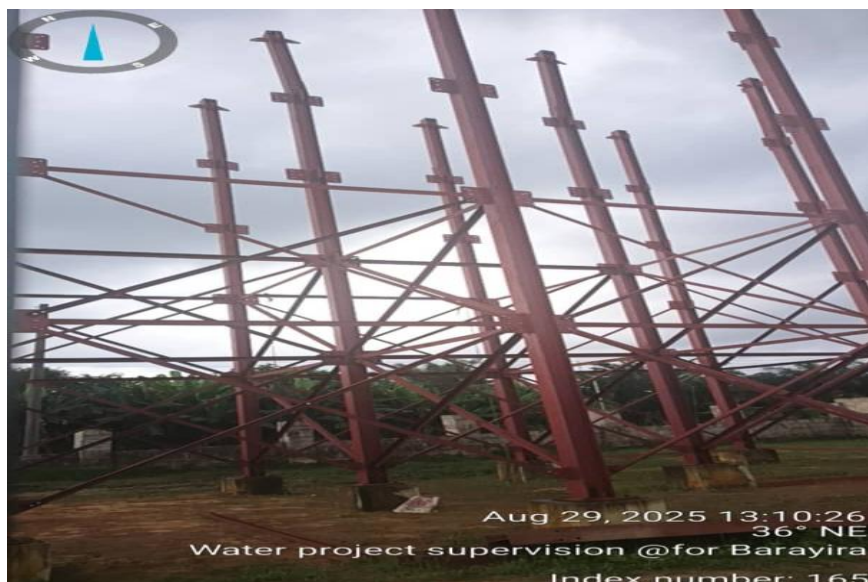
4.15 LOT 15: BARAYIRA, TAI LGA.

Work scope at Lot 15 covers the construction of 1 headwork at Barayira. Construction of perimeter fence, Staff quarter, generator house, gate house currently ongoing. Installation of elevated tank tower also ongoing.

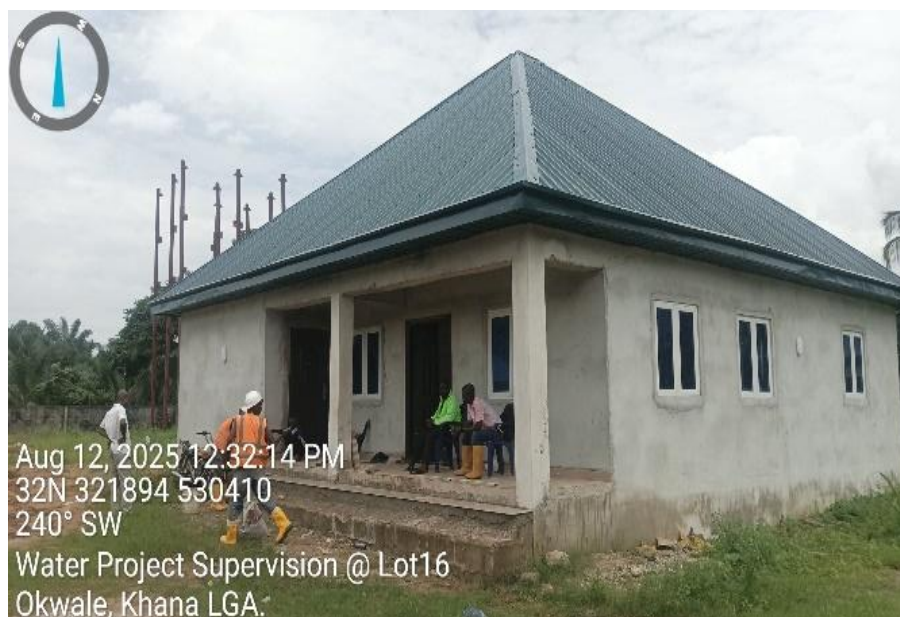
4.16 LOT 16: OKWALE/LUEKU, KHANA LGA

Activities at Lot 16 cover the construction of 2 headworks, 1 each at Lueku and Okwale communities. Construction of staff quarters to roofing level, construction of elevated and ground tanks, construction of gate house at Lueku and Okwale.

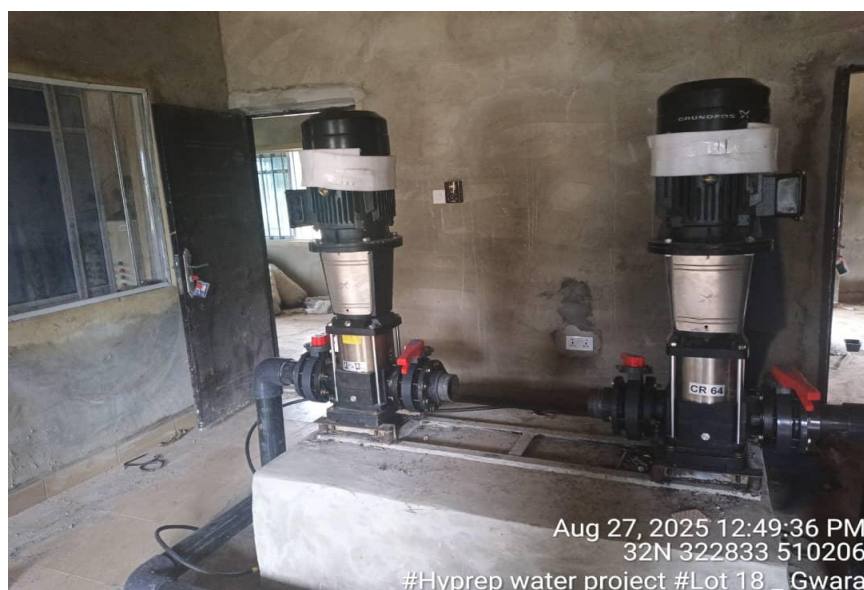
4.18 LOT 18: GWARA/EEKEN, KHANA LGA.

Activities at Lot 18 covers the construction of 1 headwork at Gwara community and 2 booster stations, 1 each at Eeken and Gurre communities respectively. Construction of ground tank and elevated tank, installation of pumps, electrical and plumbing fittings in treatment building, staff quarters, gate house, filter house also ongoing.

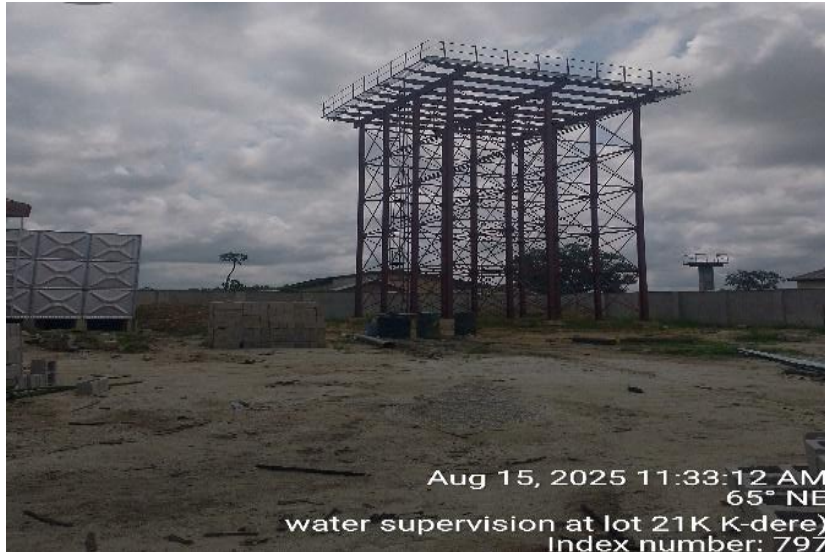
4.21 LOT 21: K-DERE, GOKANA LGA.

Activities at Lot 21 cover construction of 1 headwork at K-Dere community. Payment of homage has been done at the host community. Reticulation work is ongoing within the community while construction of perimeter fencing, ground tank and elevated tank is currently ongoing.

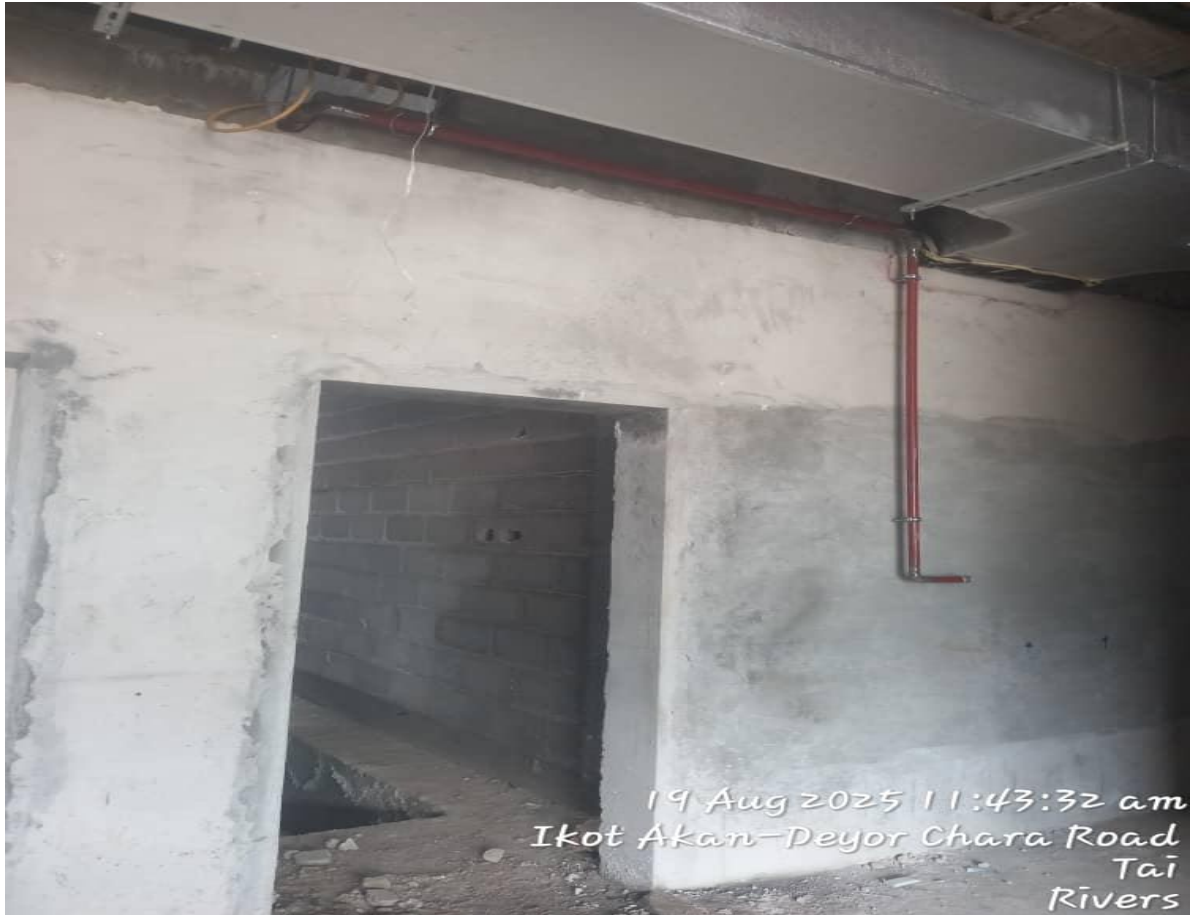
HVAC Fix and Installation of Fighting System

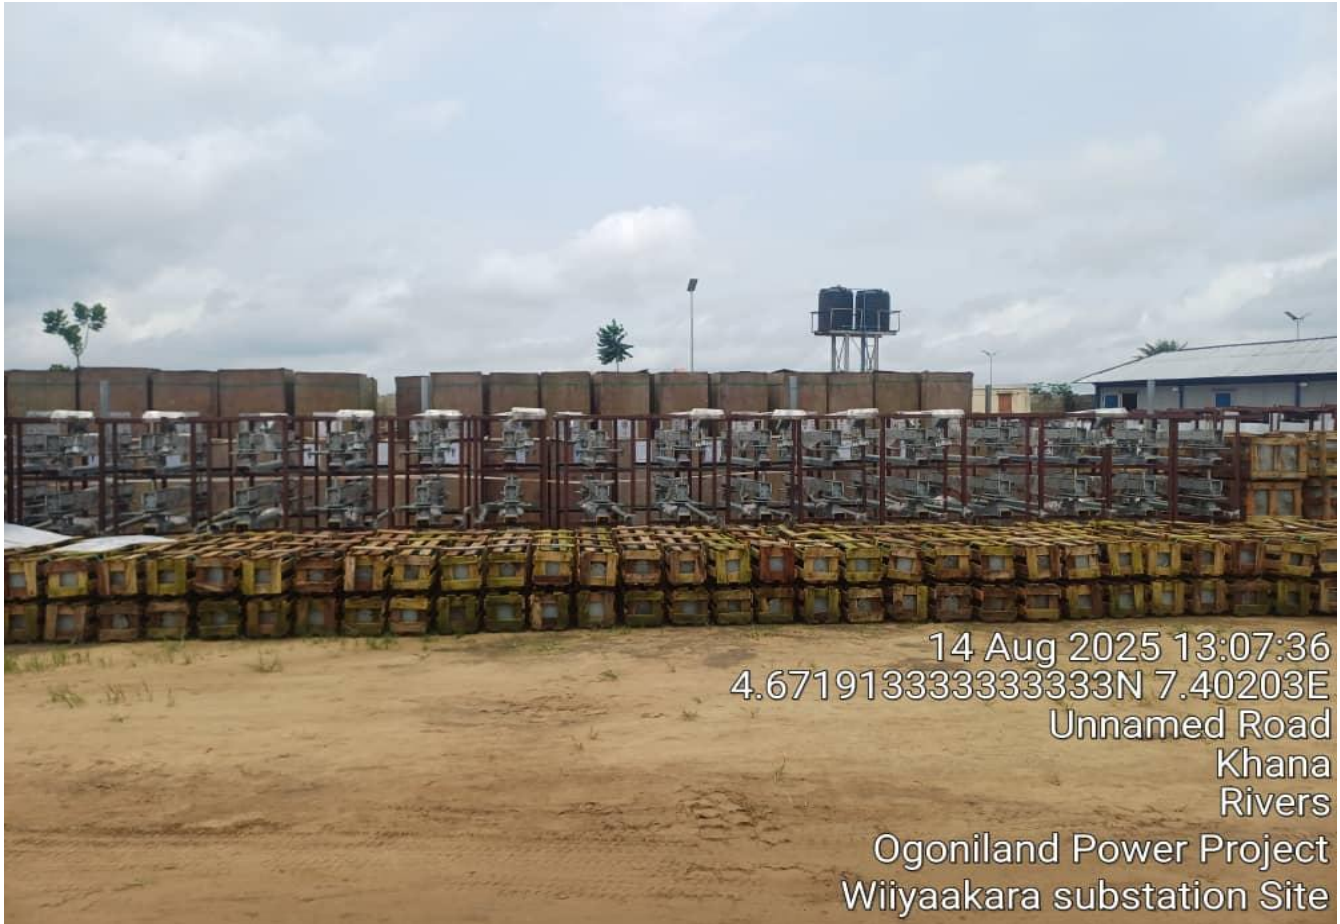
Figure1: Some Offshore Equipment at Wiiyaakara (Khana LGA) Substation

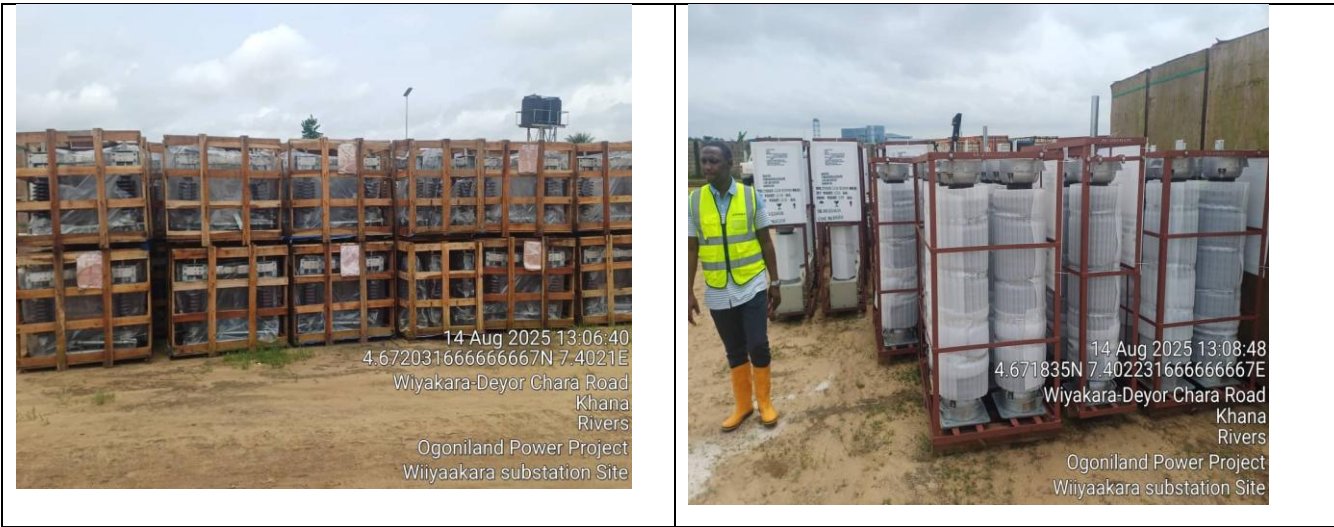
Figure 2: Offshore components of the Power Equipment at Wiiyaakara (Khana LGA) Substation
