FEDERAL MINISTRY OF ENVIRONMENT
HYDROCARBON POLLUTION REMEDIATION
PROJECT
(HYPREP)

HYPREP ACTIVITIES
REPORT
NOVEMBER
2025

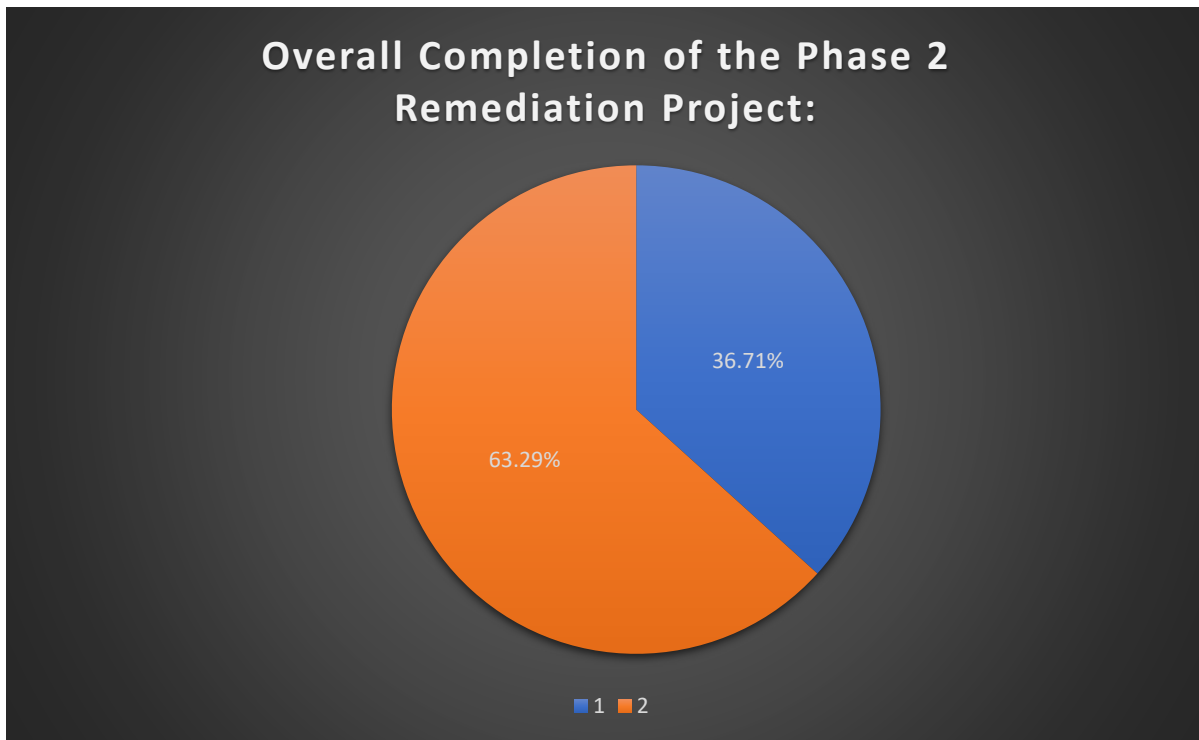
Fig. 1: Graphical Representation of the Overall Percentage Completion of the Phase

By the end of November 2025, the Phase II remediation programme had attained an overall completion rate of 38.71%, reflecting sustained progress toward the project objectives despite the technical and operational challenges associated with medium-risk sites.

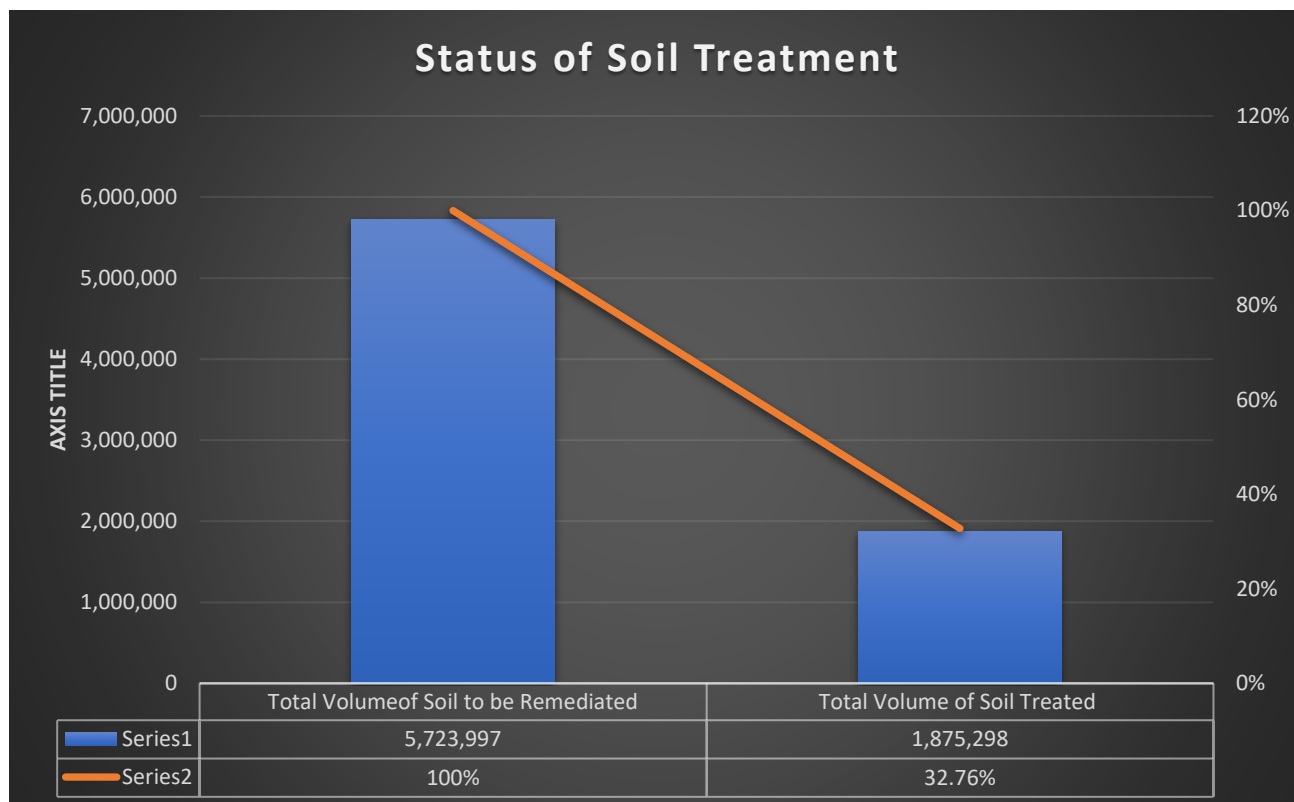
Fig. 2 : Graphical Representation of the Status of Soil Treatment

As of the end of November 2025, a cumulative total of 1,875,298 m³ of contaminated soil equivalent to 32.76% of the overall impacted volume had been successfully remediated using approved treatment methodologies.

This level of progress underscores the technical complexity and stringent operational controls necessary for the effective remediation of hydrocarbon-impacted soils across diverse geological settings and site-specific conditions.

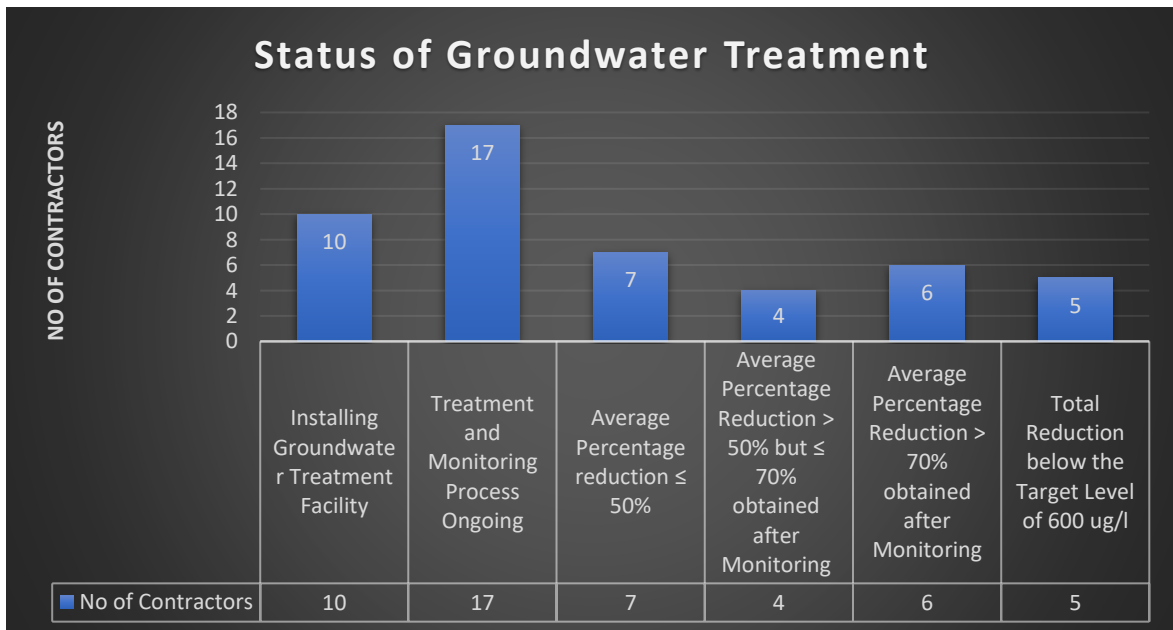
Fig. 3: Graphical Representation of Groundwater Treatment Status

During the reporting period, groundwater treatment systems were deployed at varying stages of implementation across twenty-seven (27) lots.

- System Installation Ongoing: 10 lots
- Active Treatment and Monitoring: 17 contractors
- 7 Contractors have recorded average percentage reductions between 0 and 50%
- 10 contractors have reported significant reductions in contamination levels:
 - ✓ lots (SMR 012, 025, 029, 035) recorded >50% but ≤70% reduction
 - ✓ 6 lots (SMR 002, 004, 015, 021, 026 & 033) recorded >70% reduction.
 - ✓ 5 lots (SMR 004, 015, 021, 026 & 033) have achieved TPH concentrations ≤ 600 µg/L, meeting regulatory targets.

Groundwater remediation remains a dynamic, long-term process influenced by factors such as contaminant spreading above the water table, vertical and lateral pollutant migration, and potential recontamination from adjacent zones. Continuous monitoring and system optimisation, therefore, remain critical to achieving and sustaining remediation targets.

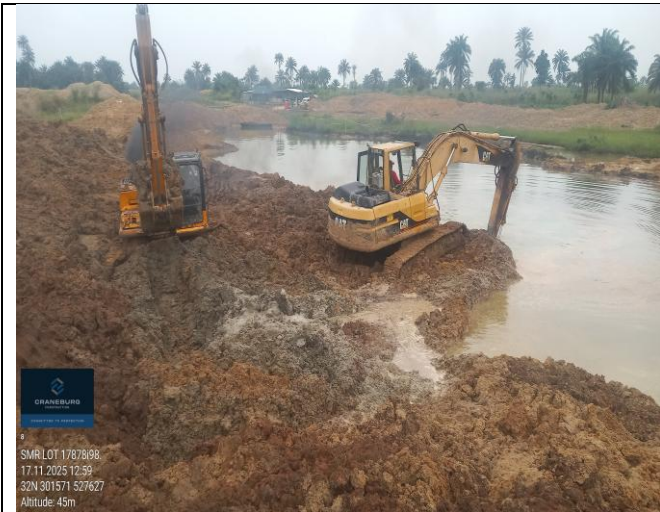
Plate 1: Excavation of impacted soil SMR Lot 017

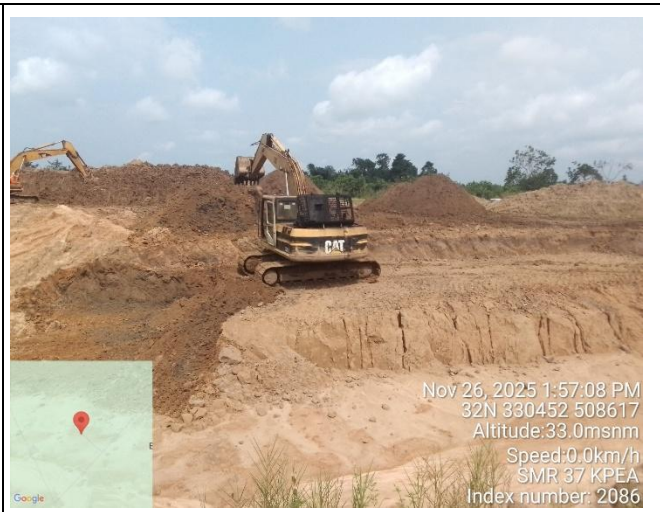
Plate 2: Excavation of Impacted Soil at SMR Lot 037

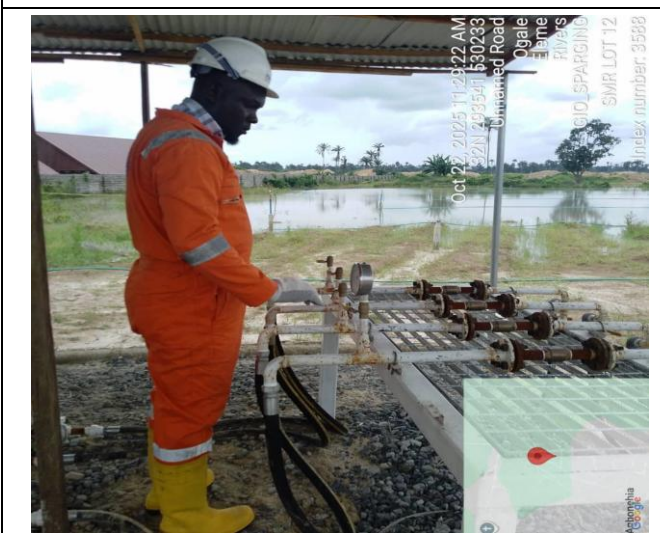
Plate 5: Biosparging Setup at SMR Lot 012

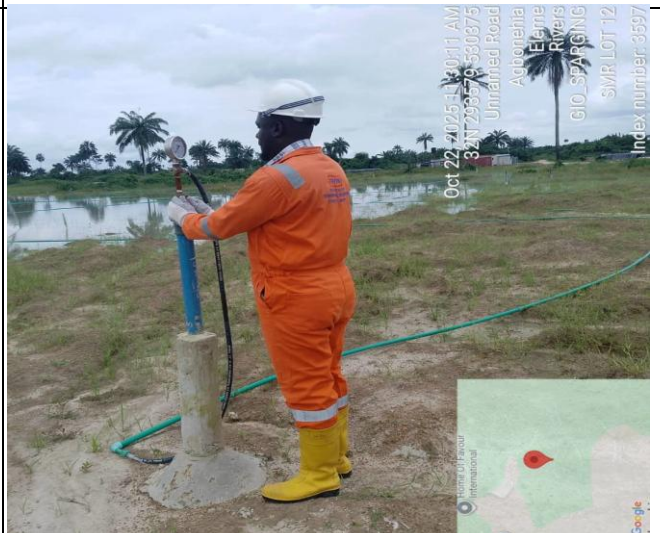
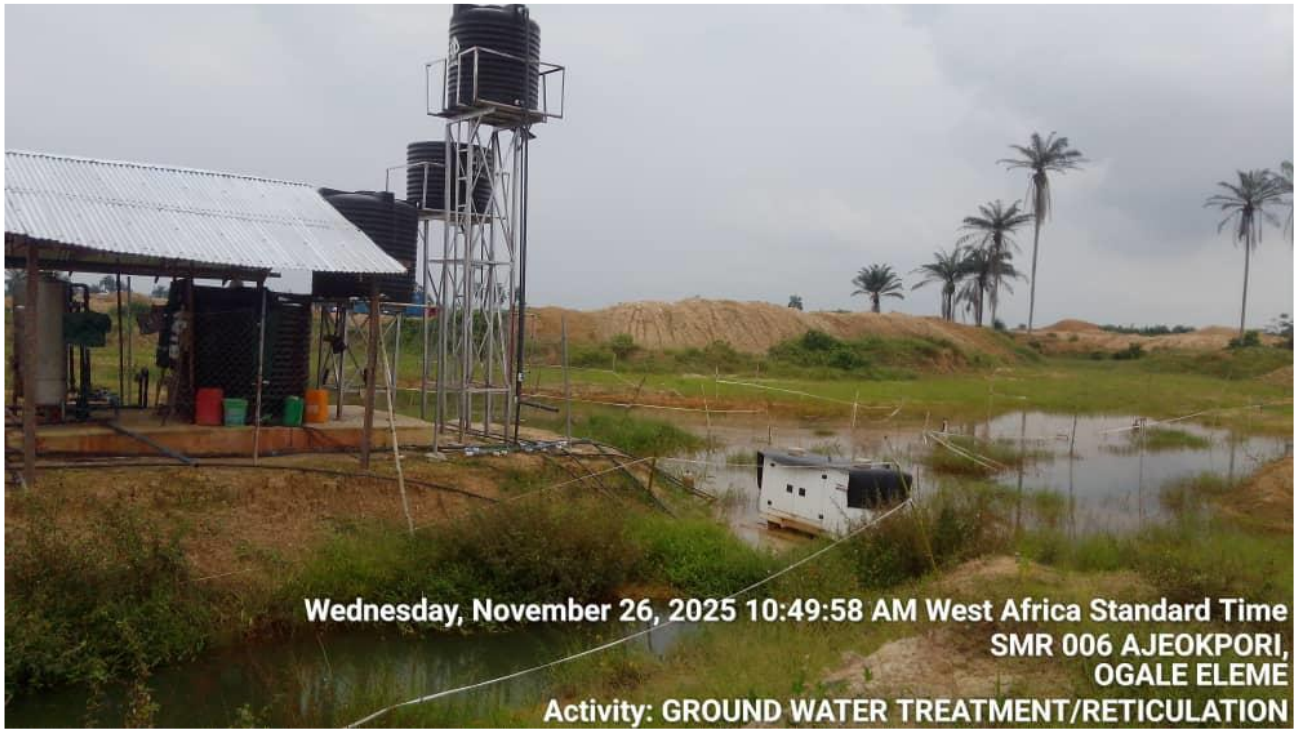
Wednesday, November 26, 2025 10:49:58 AM West Africa Standard Time
SMR 006 AJEOKPORI,
OGALE ELEME
Activity: GROUND WATER TREATMENT/RETICULATION

Plate 6: Pump and Treat Setup at Lot SMR 006

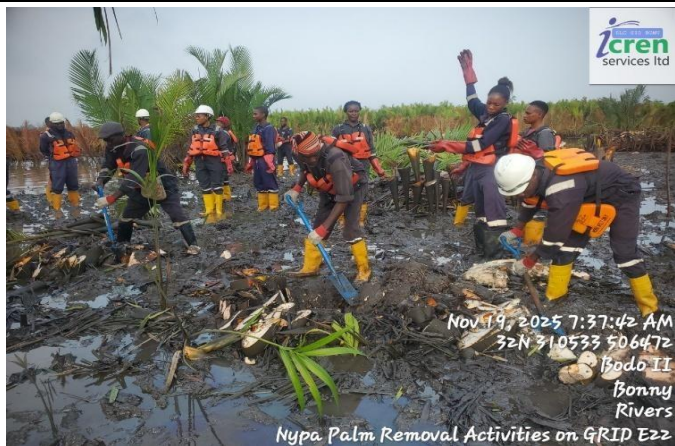
Plate 11: Nipa Palm Removal, Bomu

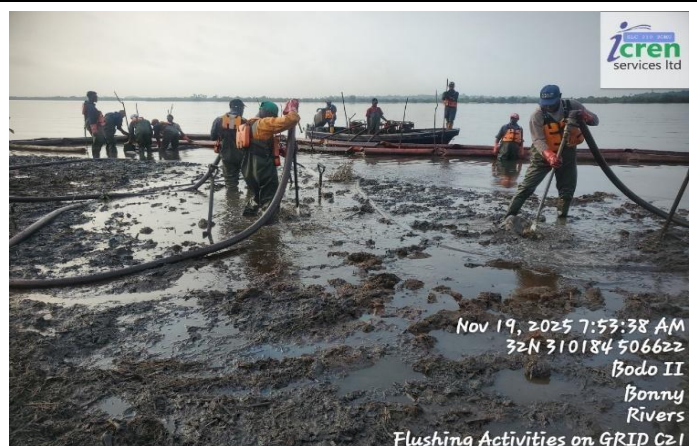
Plate 12: Sediment Flushing, Bomu

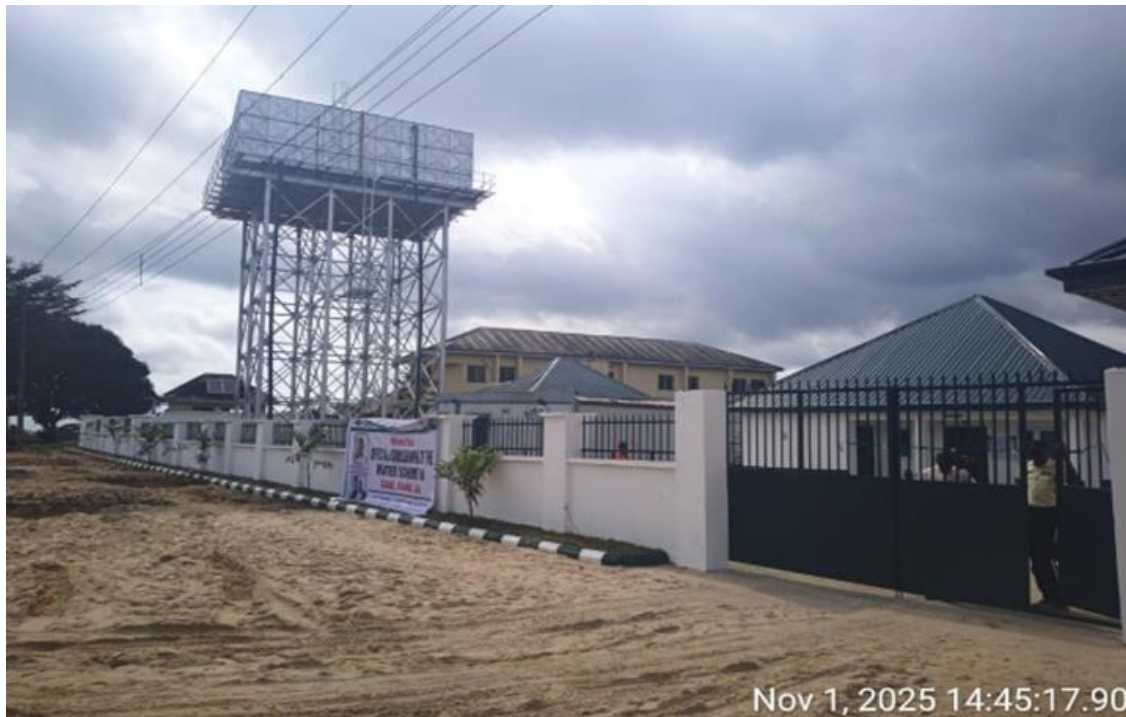
Activities under Lot 7 include the construction of two headworks, one each at the Buan and Bane communities. At the Bane station, general landscaping, painting, and the construction of both elevated and ground storage tanks have been completed. The Bane water scheme has subsequently been commissioned.

Bane Station getting set for commissioning

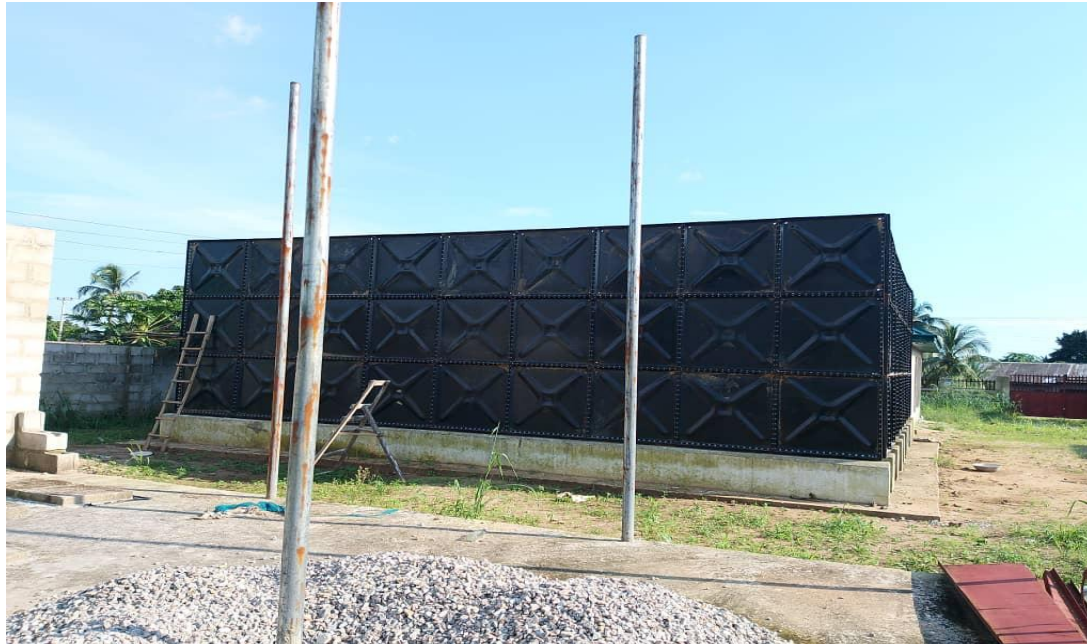
Activities at Lot 12 include construction of 1 headwork at Kpите and 1 booster station at Botem. Contractor was out of site all through the month reported.

Ground tank construction at Botem, Tai LGA.

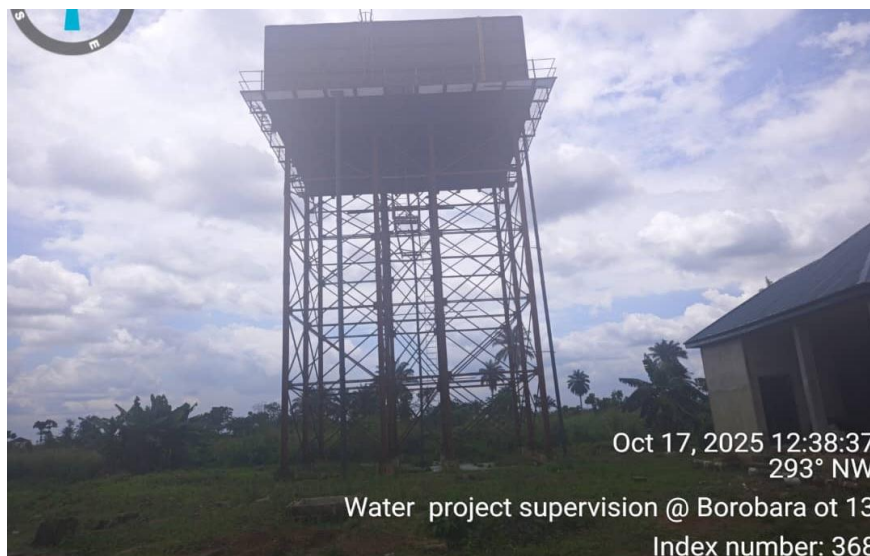
Operational maintenance is ongoing at Kporghor station while at Borobara, construction of staff quarter, generator house, filter house, tanks and valve installation ongoing.

Elevated tank construction at Borobara

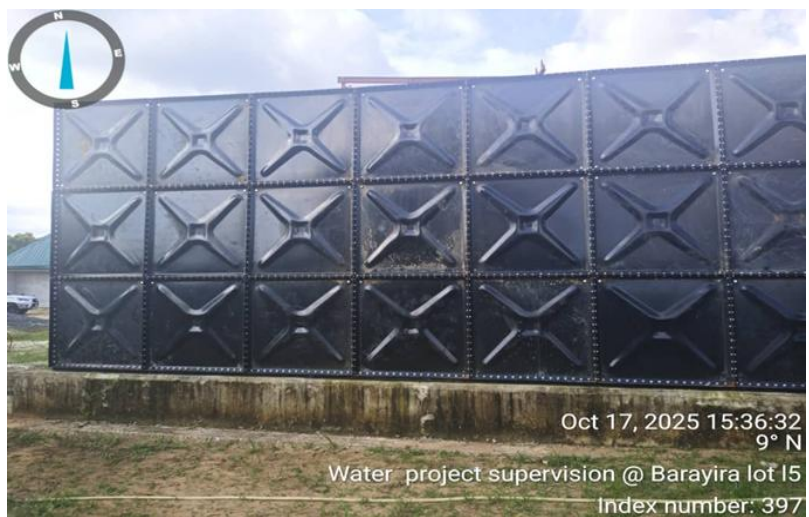
At Barayira, construction of perimeter fence, Staff quarter, generator house, gate house, installation of ground tank is currently ongoing.

Ground tank construction at Barayira

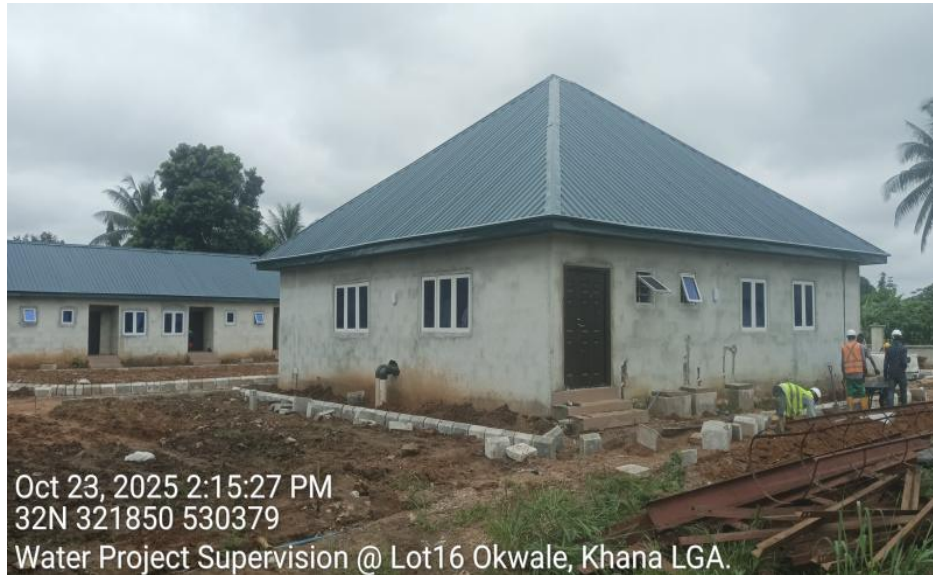
Laying of kerbs and general on-going, Okwale

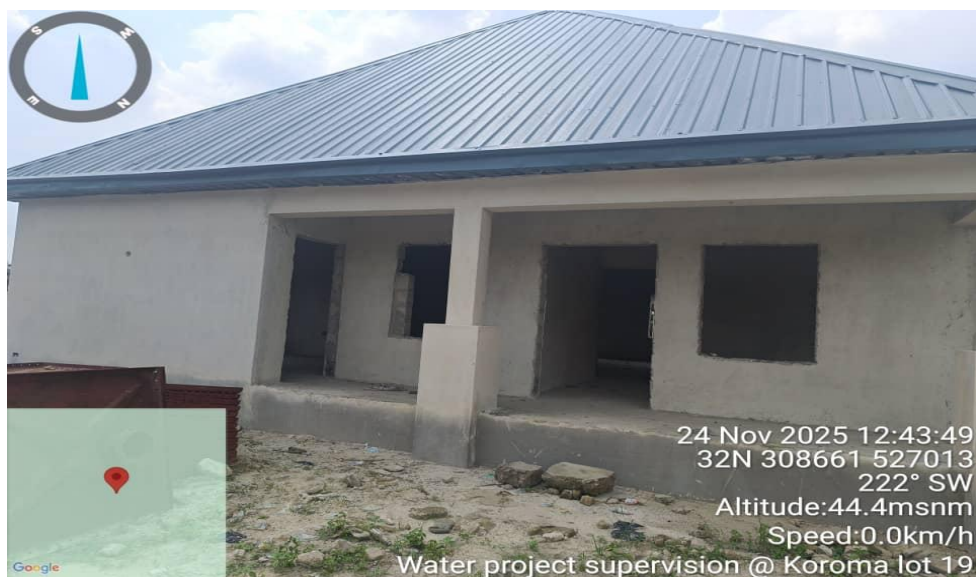
Construction of treatment building, filter house, staff quarters, generator house, ground tank and elevated tanks and office setting at Koroma, while the Bunu station is on operational maintenance.

Treatment building at Koroma

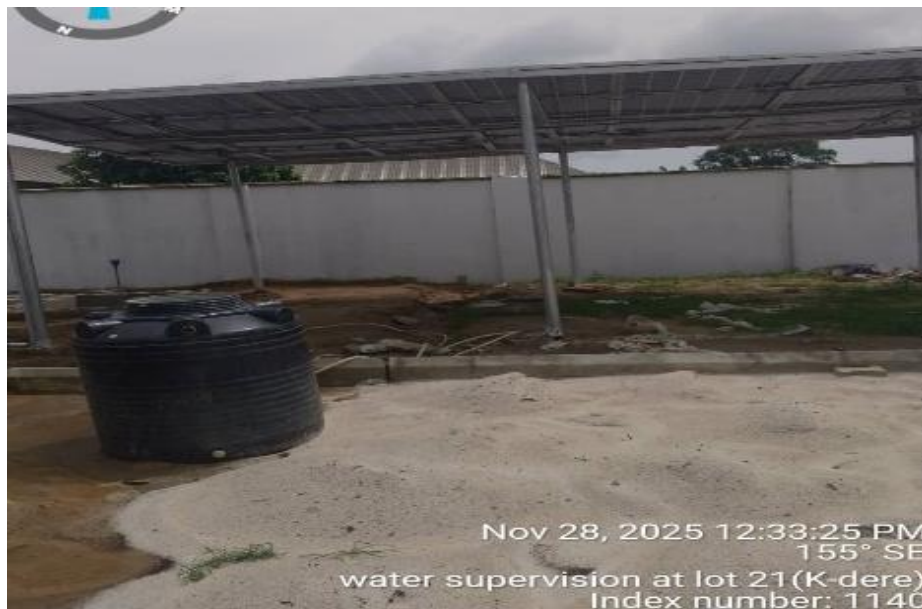
Activities at Lot 21 cover construction of 1 headwork at K-Dere community. Payment of homage has been done at the host community. Reticulation work is ongoing within the community while construction of perimeter fencing, ground tank and elevated tank is currently ongoing.

Solar installation at K-Dere site

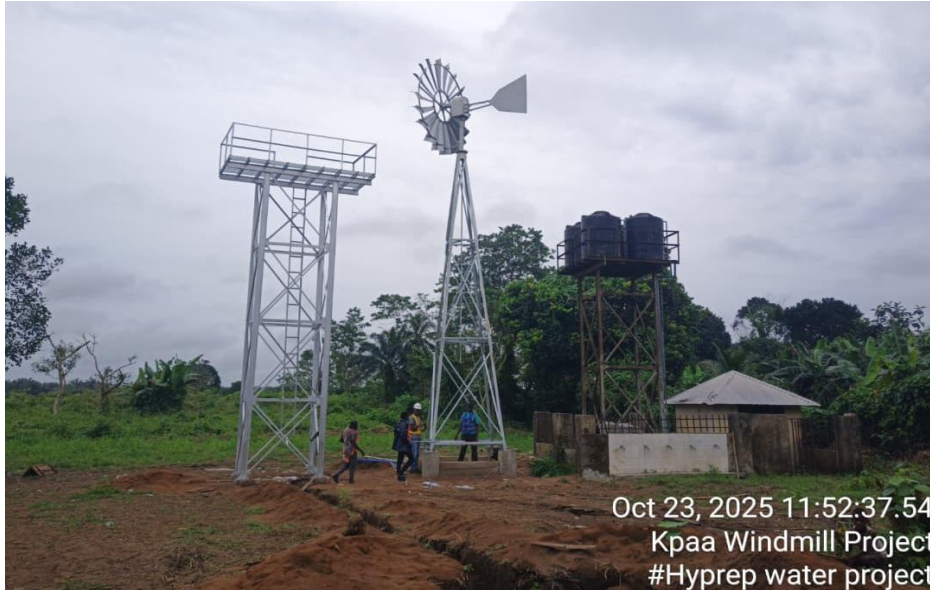
Activities for the windmill powered water projects include the construction of 1 windmill powered water scheme each at Luekue Bagha, Bere, Yaataa, Kalaoko, Kpaa and Wiisueko communities in Khana LGA. Wind turbine has been installed at Kpaa.

Windmill construction at Kpaa

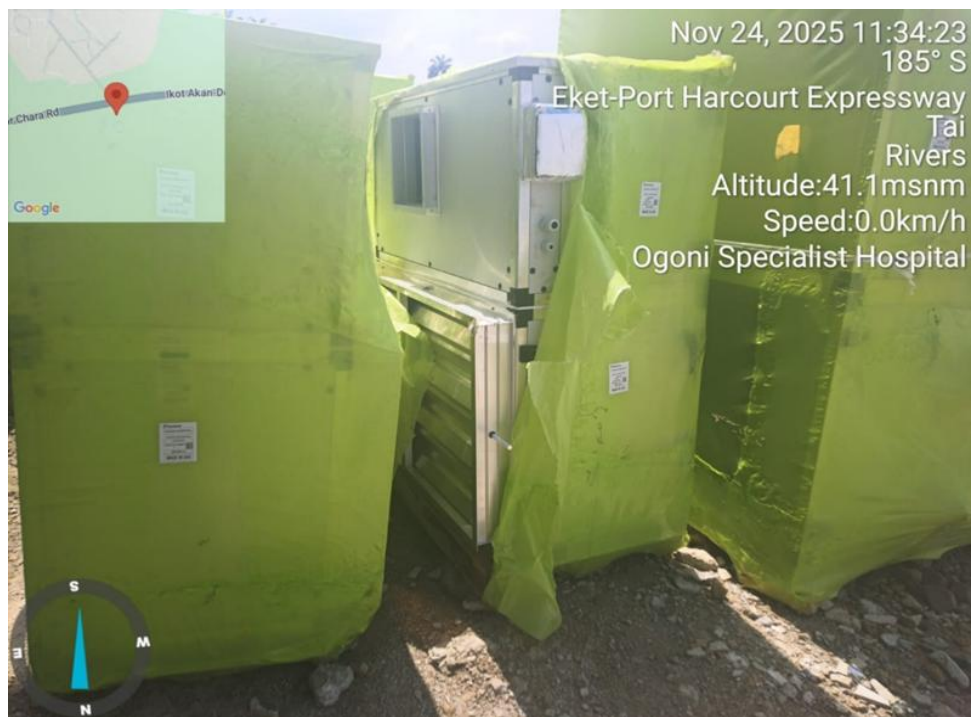
Air Handling Units (AHU)

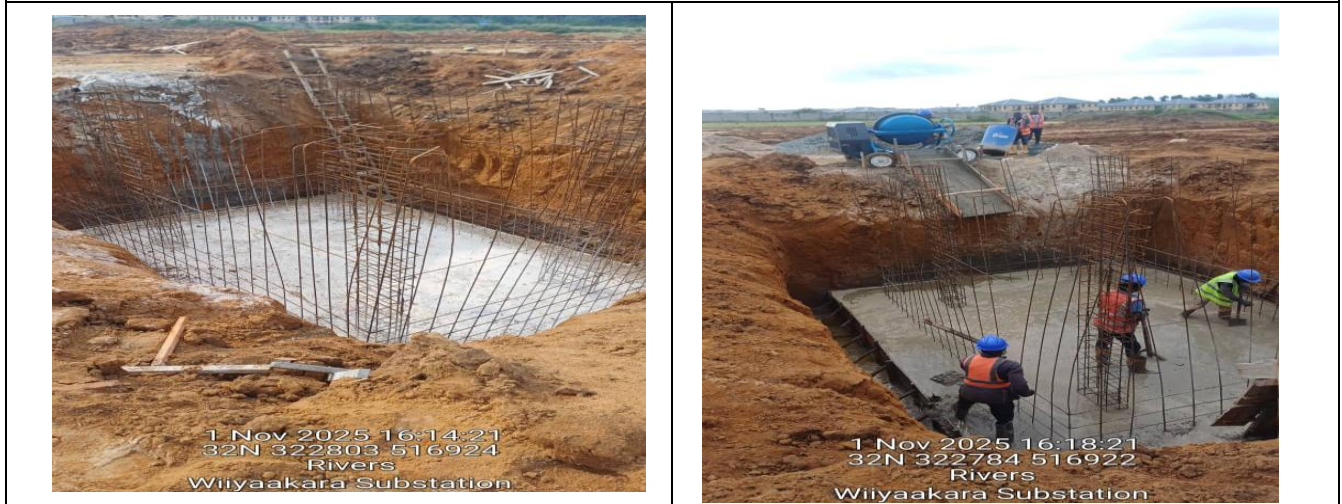
Fig. 2: Preparation of 132kv gantry bases at Wiyakara substations
