## 1.0 REMEDIATION WORKS

### 1.1. STATUS OF ON-GOING REMEDIATION WORKS AT PHASE 1 BATCH 1 SITES

## **1.8 QUALITY ASSURANCE / QUALITY CONTROL (QAQC) MONITORING OF SITES**

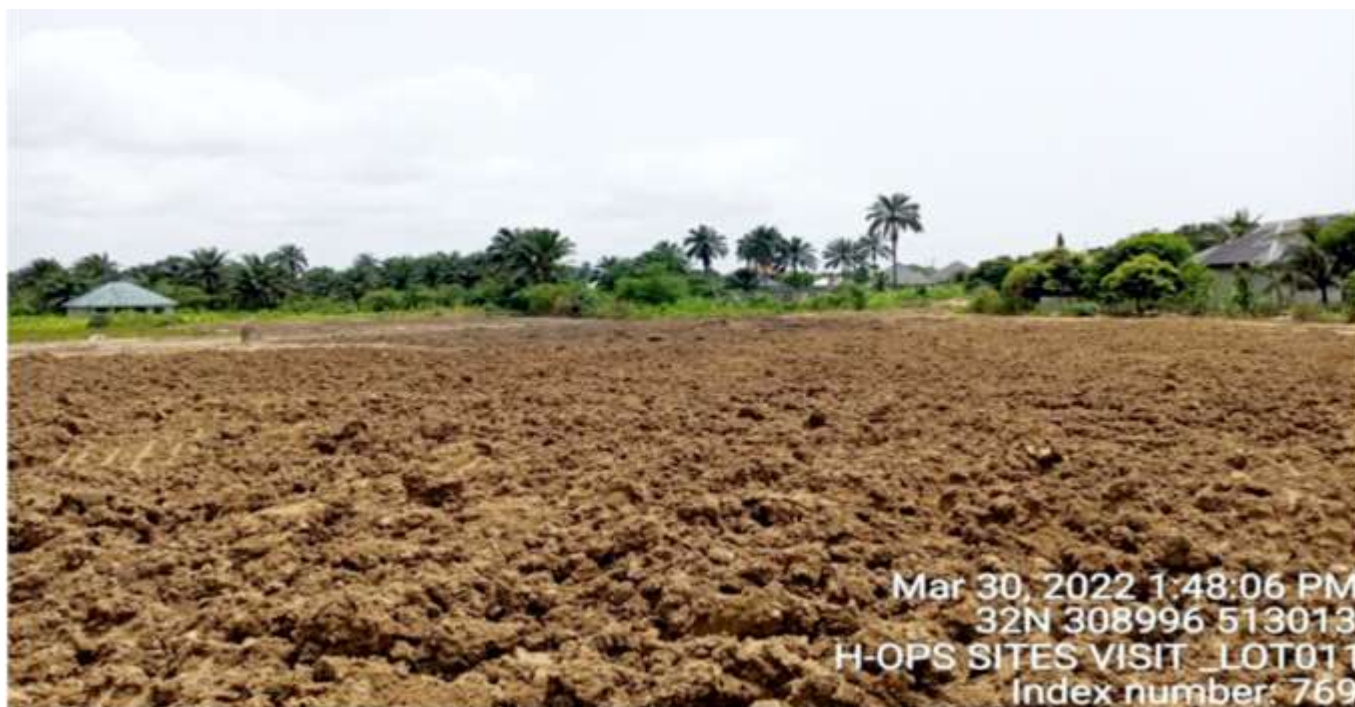
Plate 1.1: A panoramic view of Lot 011 at Debon, Bodo/Mogho, Gokana L.G.A. where final backfilling of excavated pits with the treated soil was recently concluded. (Contractor: MOSVINNY NIG. LTD).

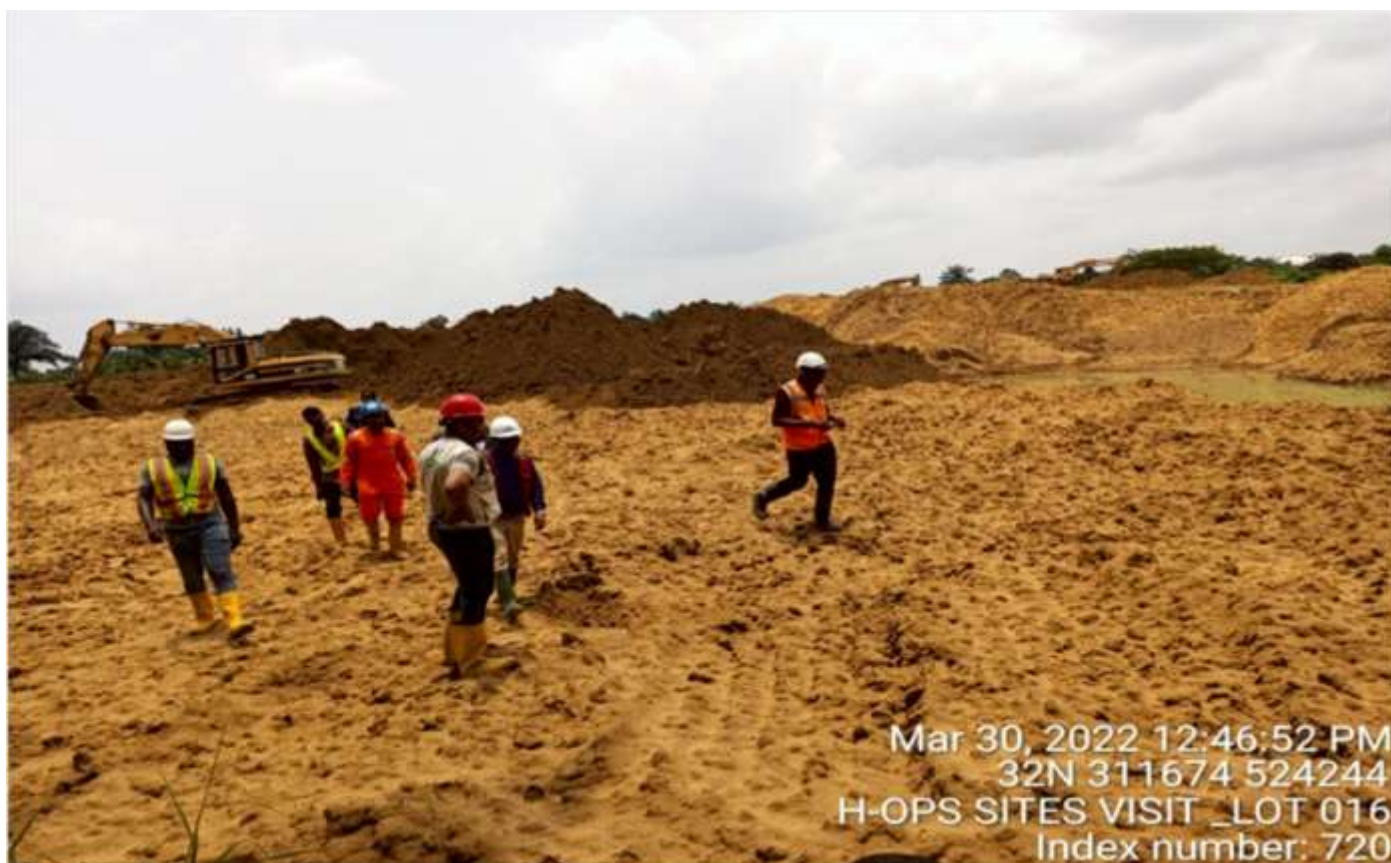
Plate 1.2: On-going backfilling of excavated pits with treated soil at Lot 016, Buemene Korokoro Well 005, Tai L.G.A. (Contractor: NEWLIN WEST AFRICA LTD)

Ø Lot 016 is at advanced stage of completion of backfilling of treated soil.

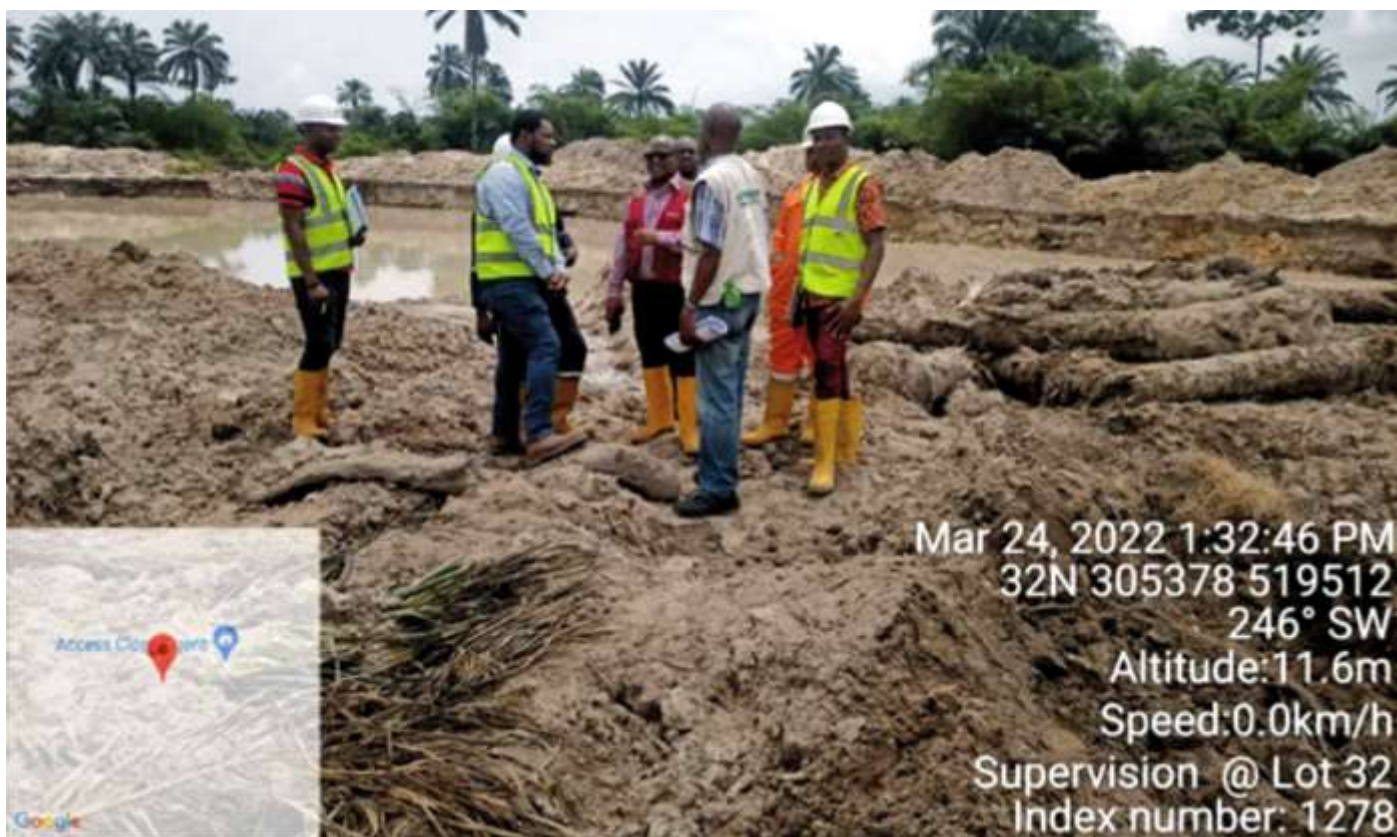
Plate 1.3: Excavation of impacted soil for treatment in progress at Lot 032 B-Dere/Gio, Gokana/Tai L.G.As. Remediation Contractor -MOSITO ENVIRONMENTAL LTD.

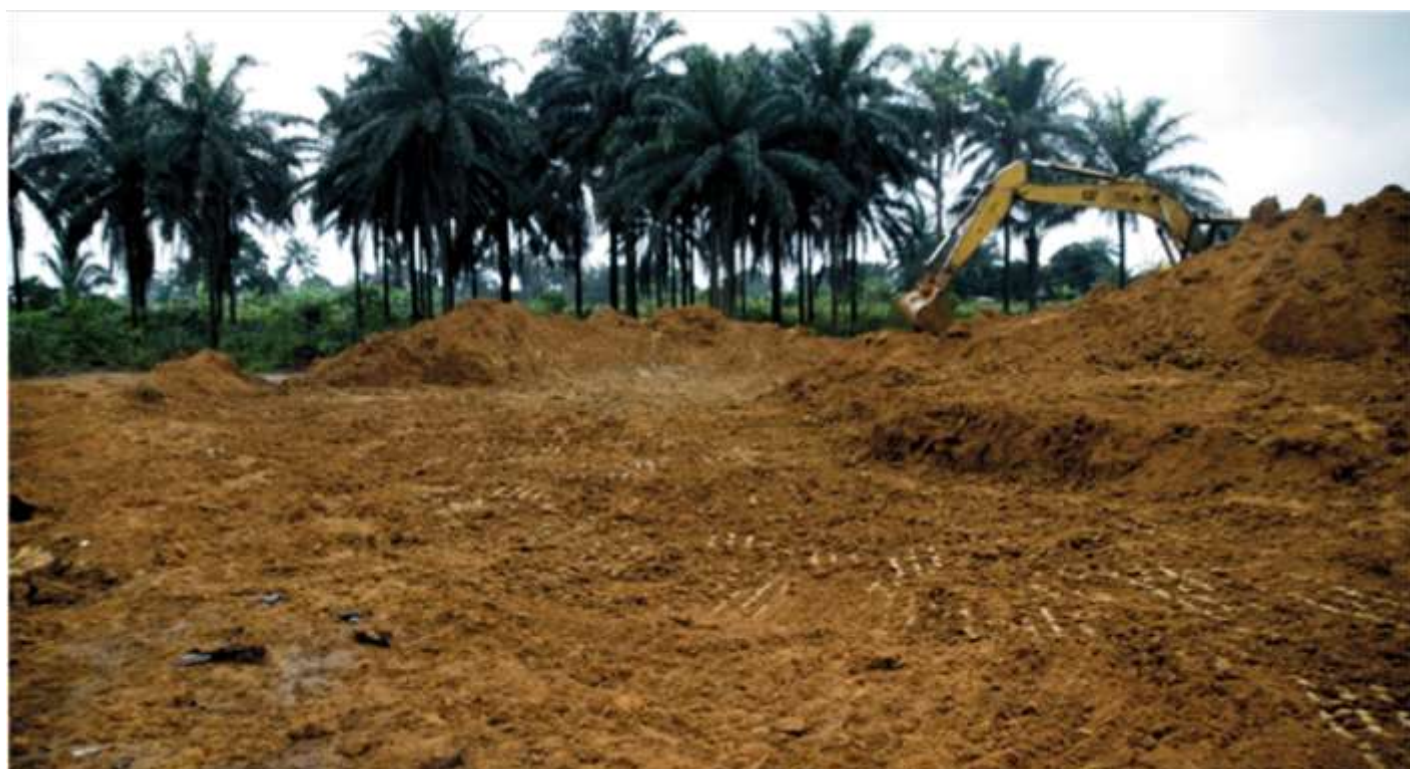
Plate 1.4: Final stage of backfilling, site leveling and landscaping in progress at Lot 029 (Bara Alue, Tai L.G.A) as at 3rd March, 2022. Remediation Contractor -WEAFRI WELLS SERVICES LTD.

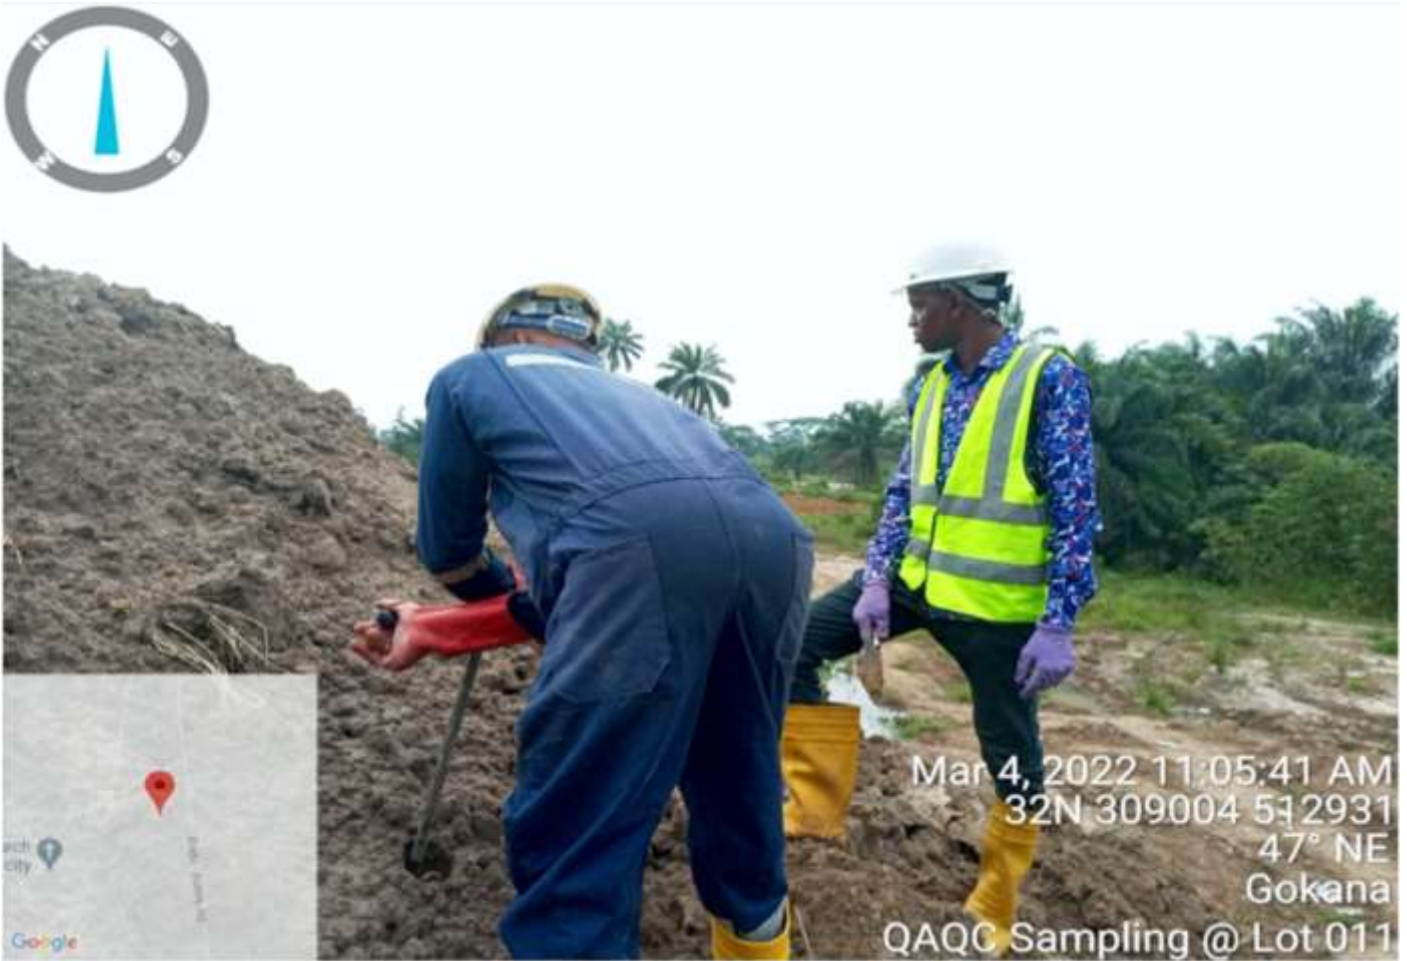
Plate 1.5: Scientific Officers from the Operations Unit of HYPREP collecting final QA/QC Monitoring Samples from treated soil heaps at Lot 011: Debon Section B, Bodo/ Mogho, Gokana L.G.A). Remediation Contractor -MOSVINNY NIGERIA LTD.

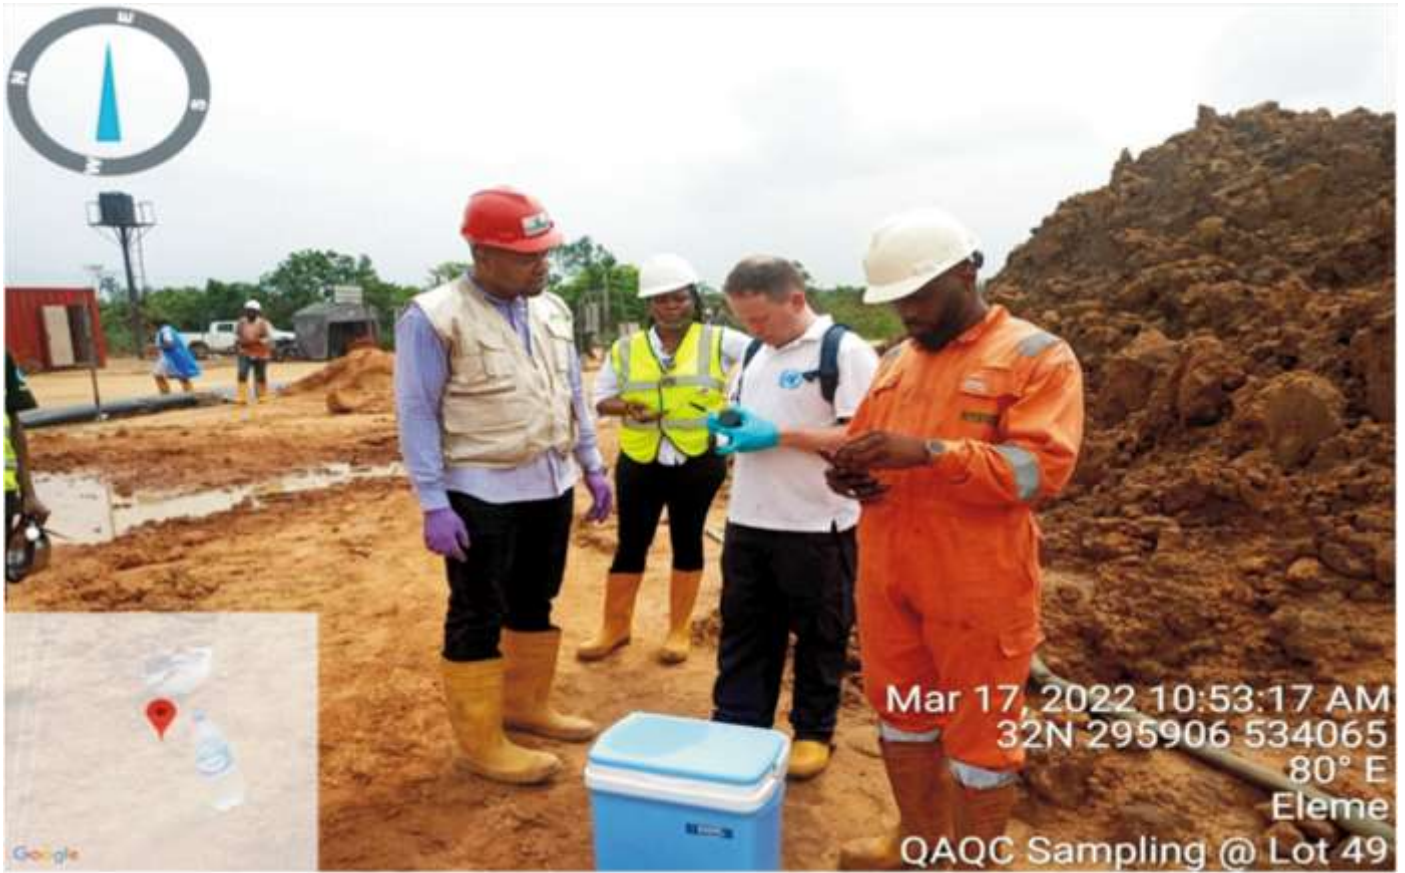
Plate 1.6: The UNEP Focal Person labelling a 60ml amber jar for collection of soil samples at Lot 049.(Lot 049 Contractor: ENVIRON CONSULT & REMEDIAL SERVICES LTD)

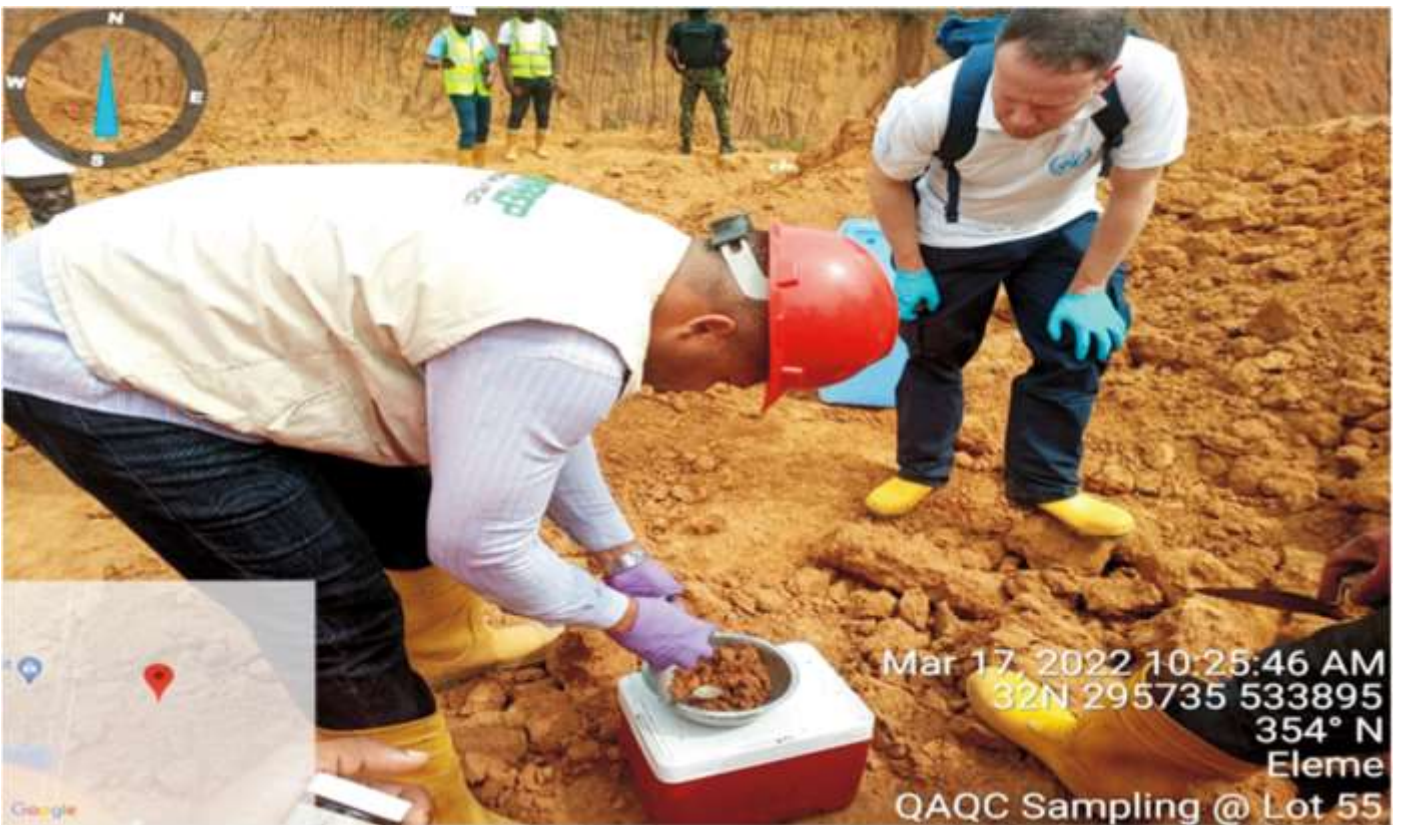
Plate 1.7: The Joint UNEP/HYPREP Team collecting soil samples from remediated stockpiles at Lot 055 in Okuluebu 2 (Ajeokpori Well 3), Ogale, Eleme L.G.A.(Lot 055 Contractor: ADG)

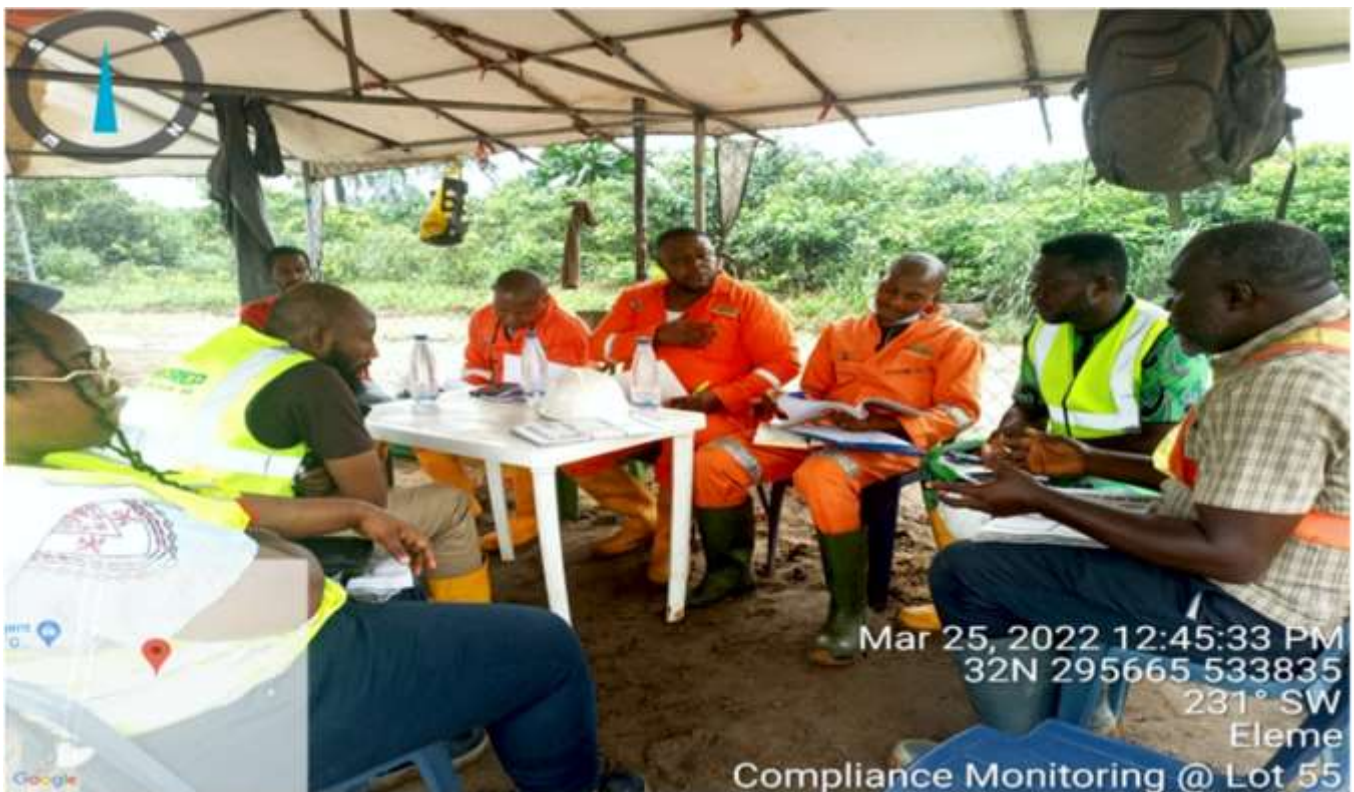
Plate 1.10: Checks by NOSDRA Officers during her compliance monitoring at Lot 055 – Okuluebu2, Ogale, Eleme L.G.A.(Lot 055 Contractor: ADG INTERNATIONAL LTD)

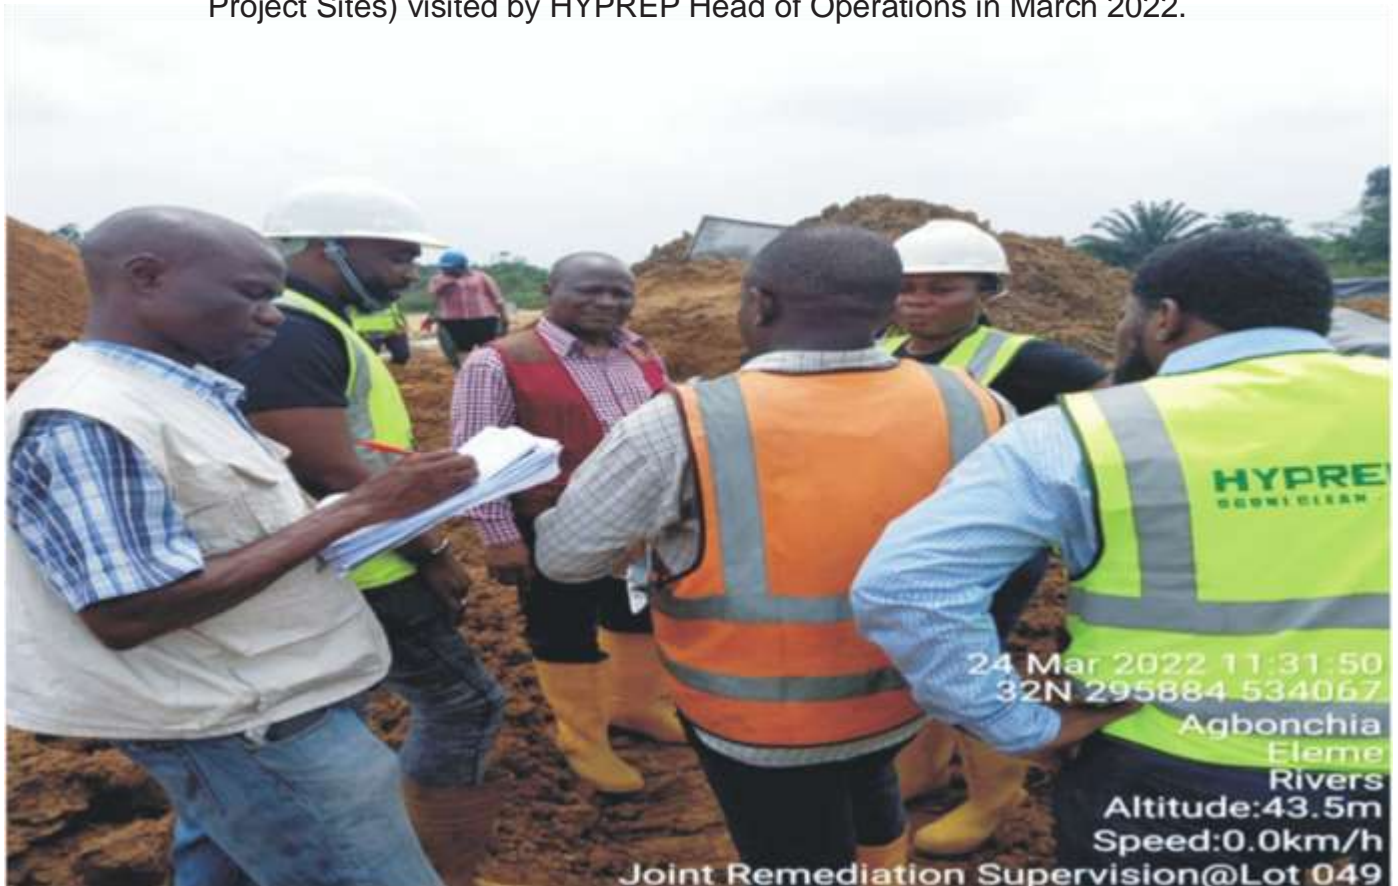
Plate 1.5: Head, Operations (in red work jacket) in an interaction with the Site Contractor Representative at LOT 049 Okuluebu, Ogale, Eleme L.G.A during one of the former's leadership commitment sites visits in March 2022.(Remediation Contractor: Environ Consult and Remedial Services Ltd)

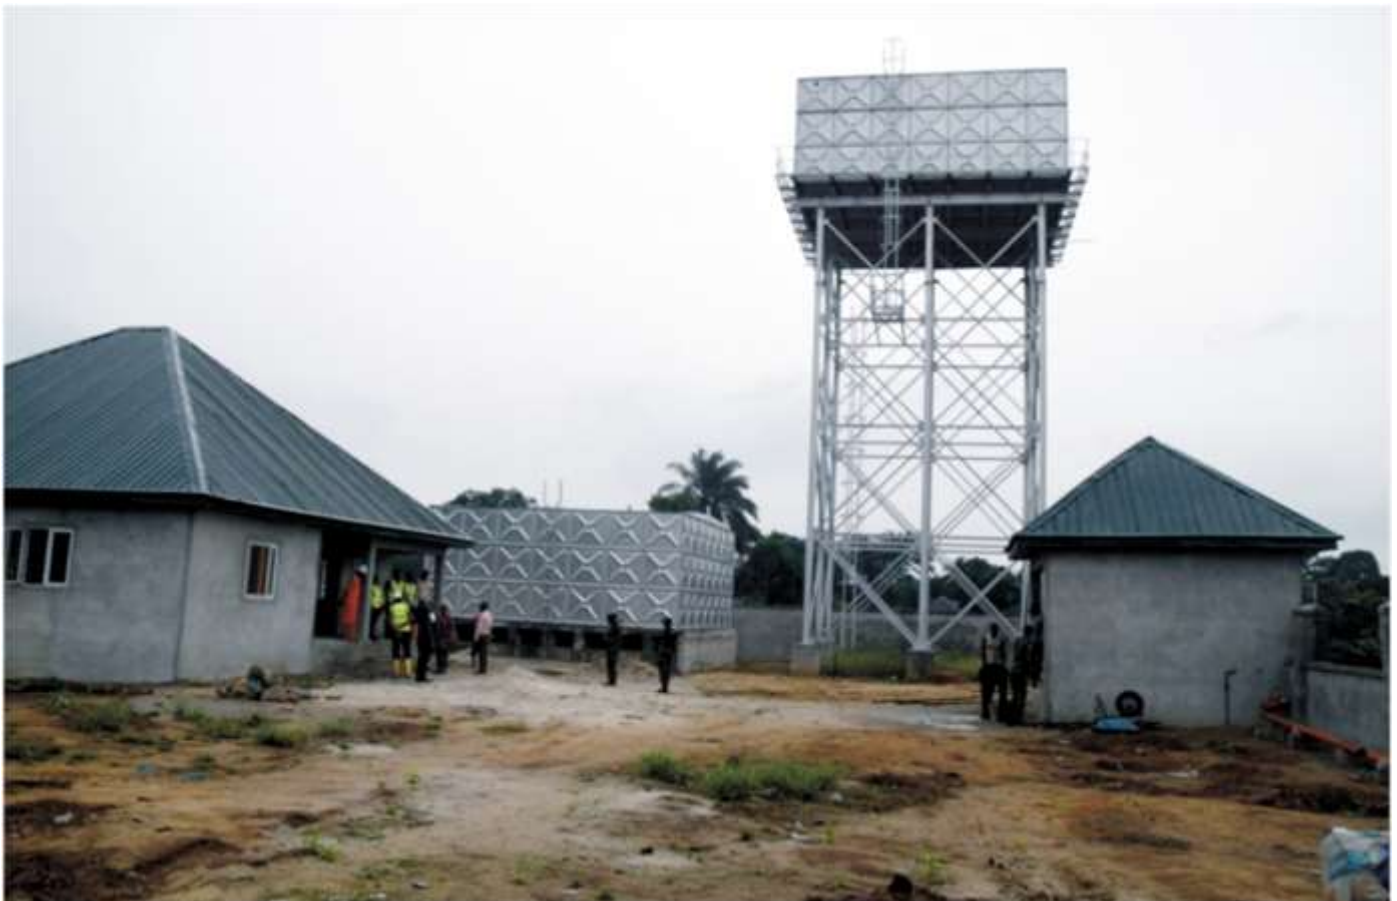
Plate 1.7: Head of Operations visit to HYPREP Potable Water Supply Project under construction at Korokoro, Tai L.G.A during his Supervisory field visit on 3<sup>rd</sup> March, 2022.

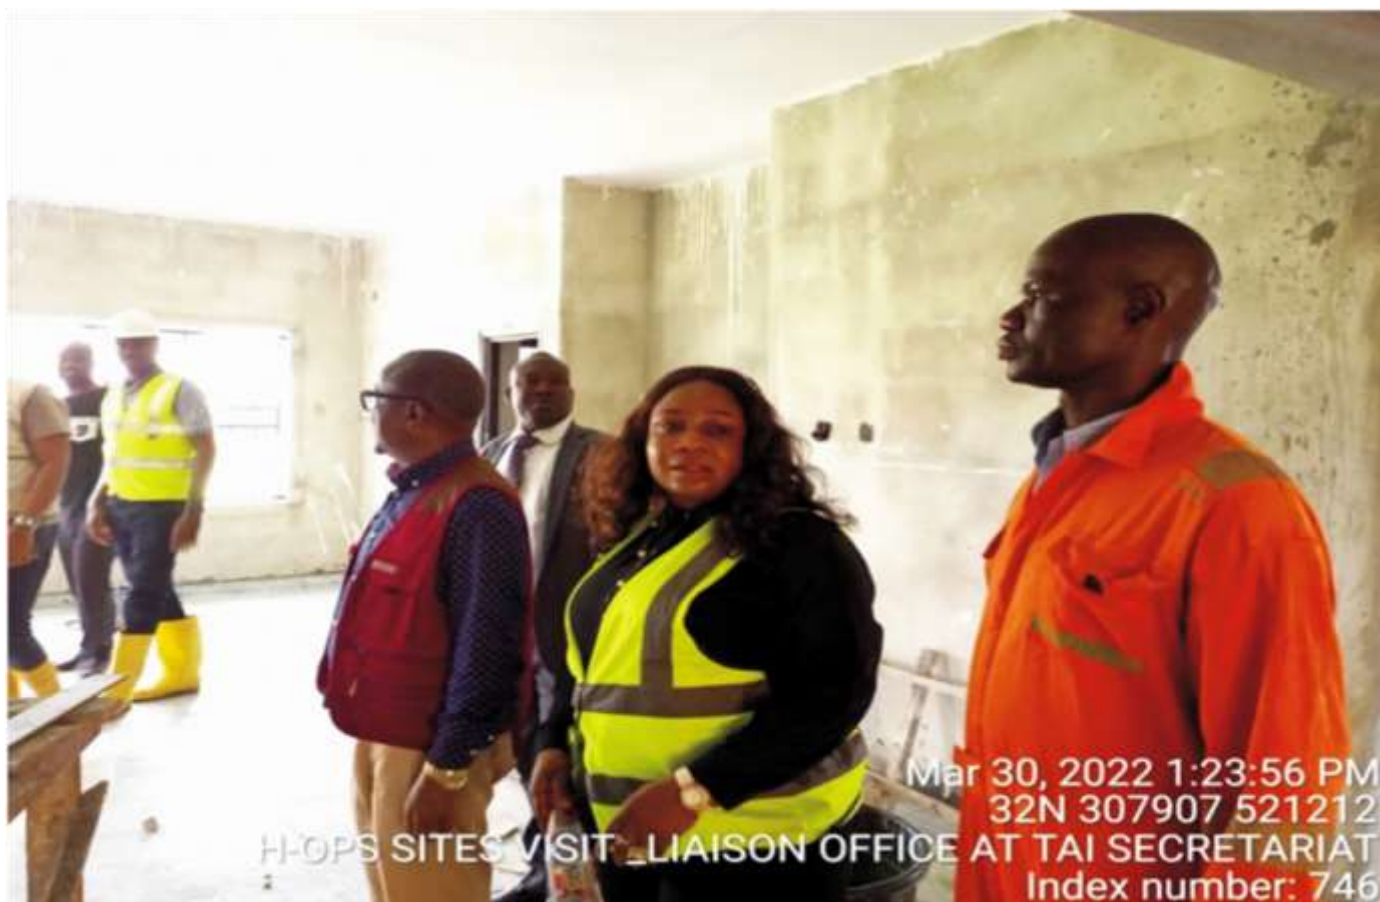
Plate 1.7: Head of Operations visit to HYPREP Liaison Office at Tai Local Government Council Secretariat, Saakpenwa under construction during his Supervisory field visit on 30<sup>th</sup> March, 2022.

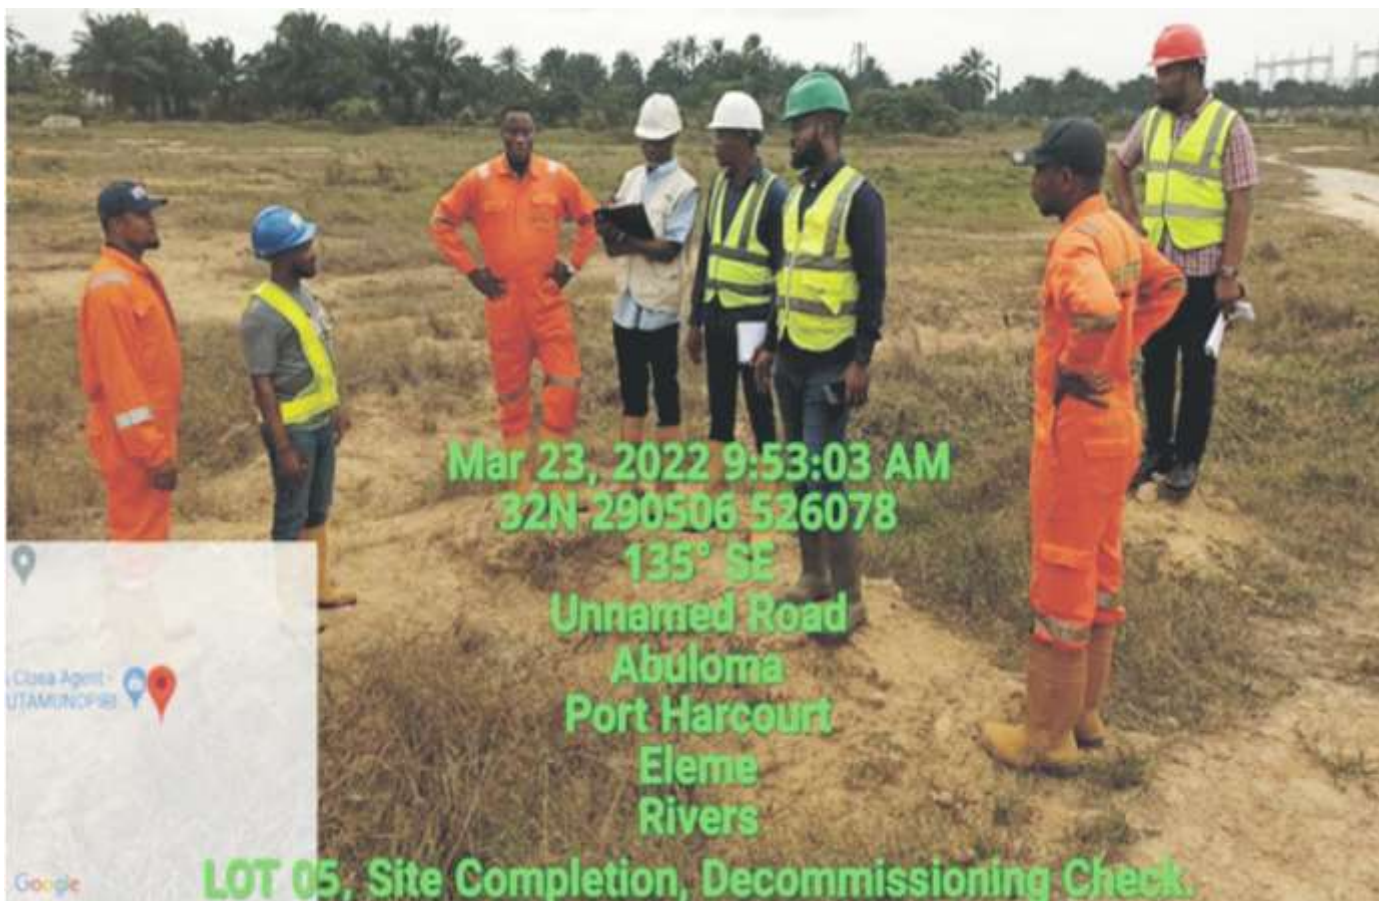
Plate 1.9: Team of Remediation Supervisors undertaking checks on levels of compliance with completion of remediation earthworks and decommissioning of site facilities at Lot 005 (Nkeleoken –Alode, Eleme L.G.A).

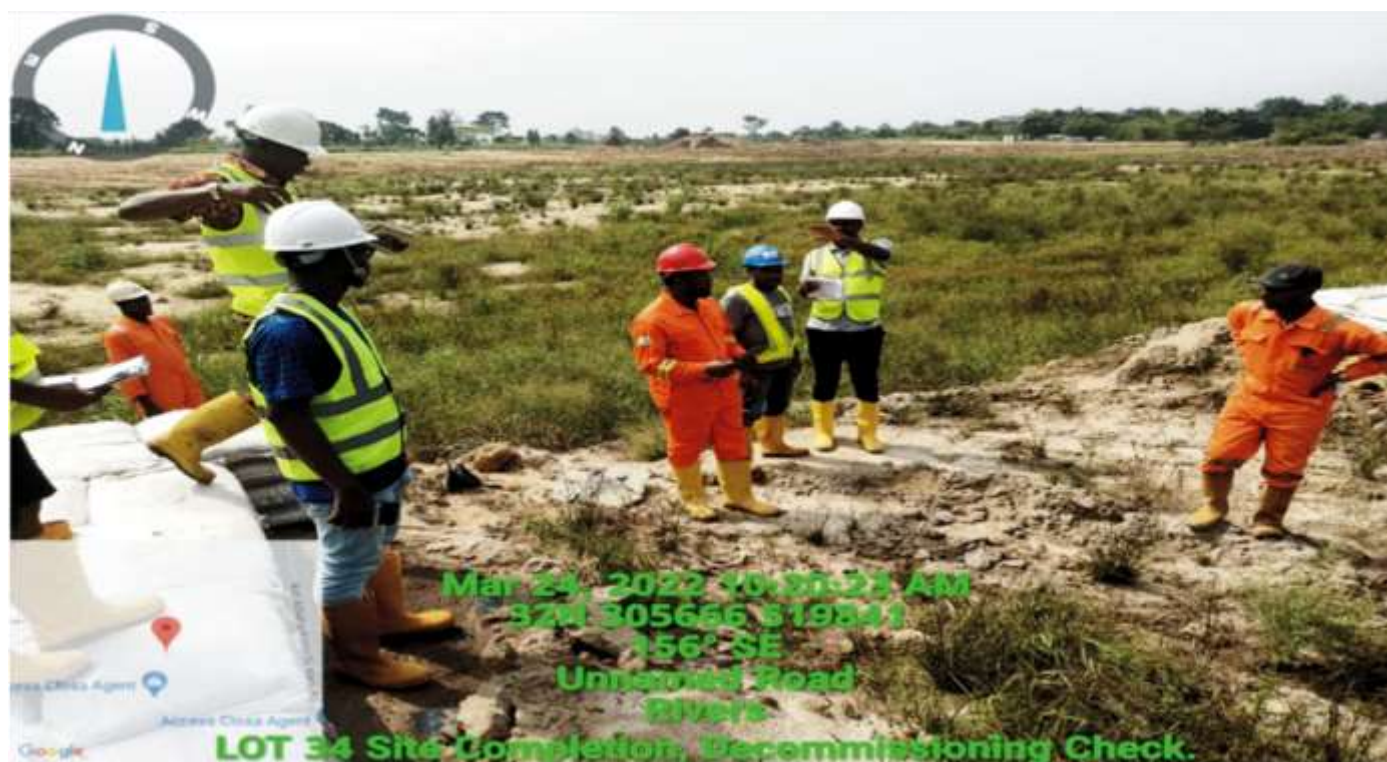
Plate 1.10: Team of Remediation Supervisors undertaking checks on levels of compliance with completion of remediation earthworks and decommissioning of site facilities at Lot 034 (B.Dere/Gio, Gokana / Tai L.G.As).

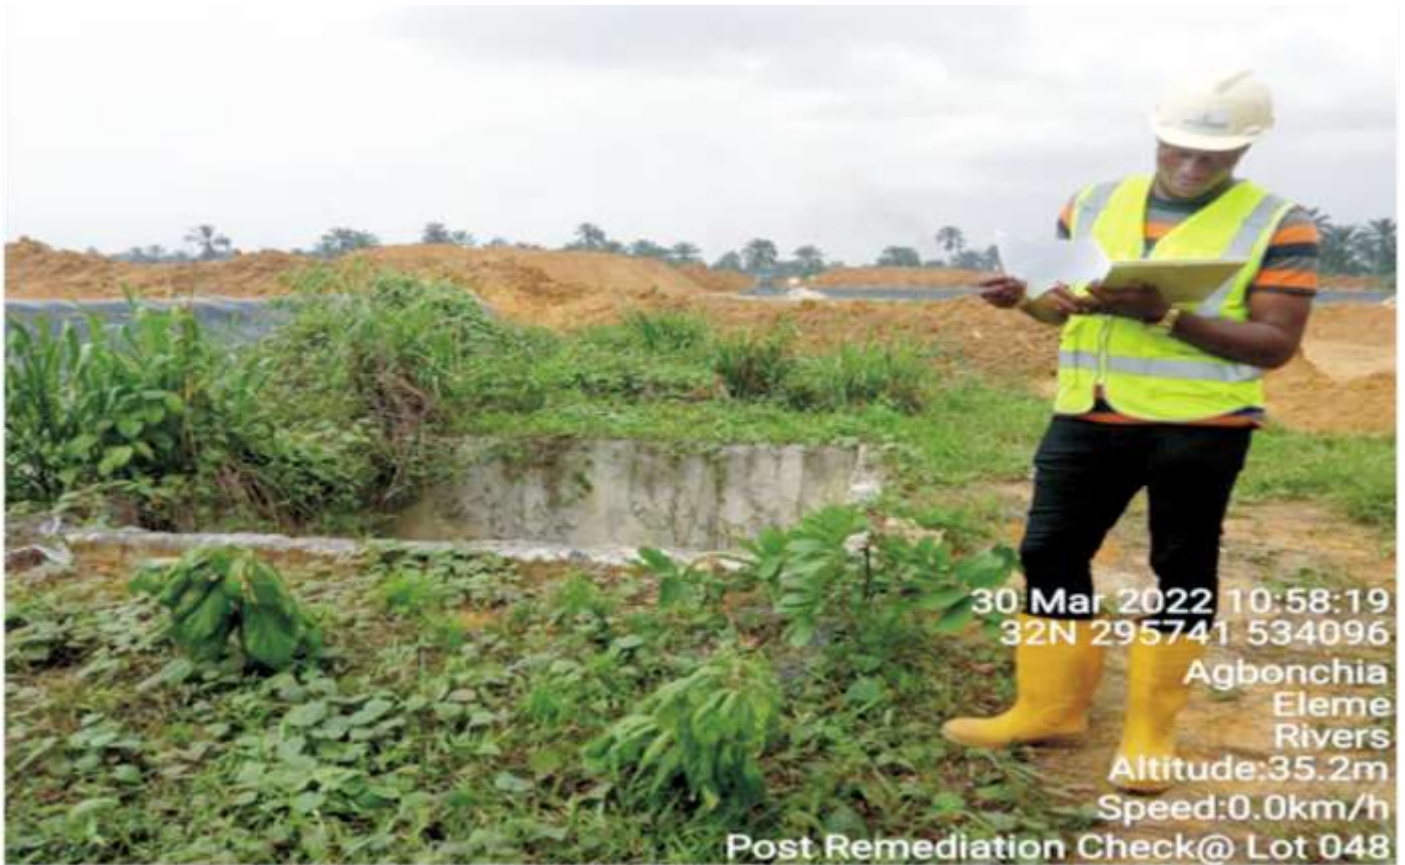
Plate 1.11: Team of Remediation Supervisors undertaking checks on levels of compliance with completion of remediation earthworks and decommissioning of site facilities at Lot 048 (Okuluebu, Ogale, Eleme L.G.A).

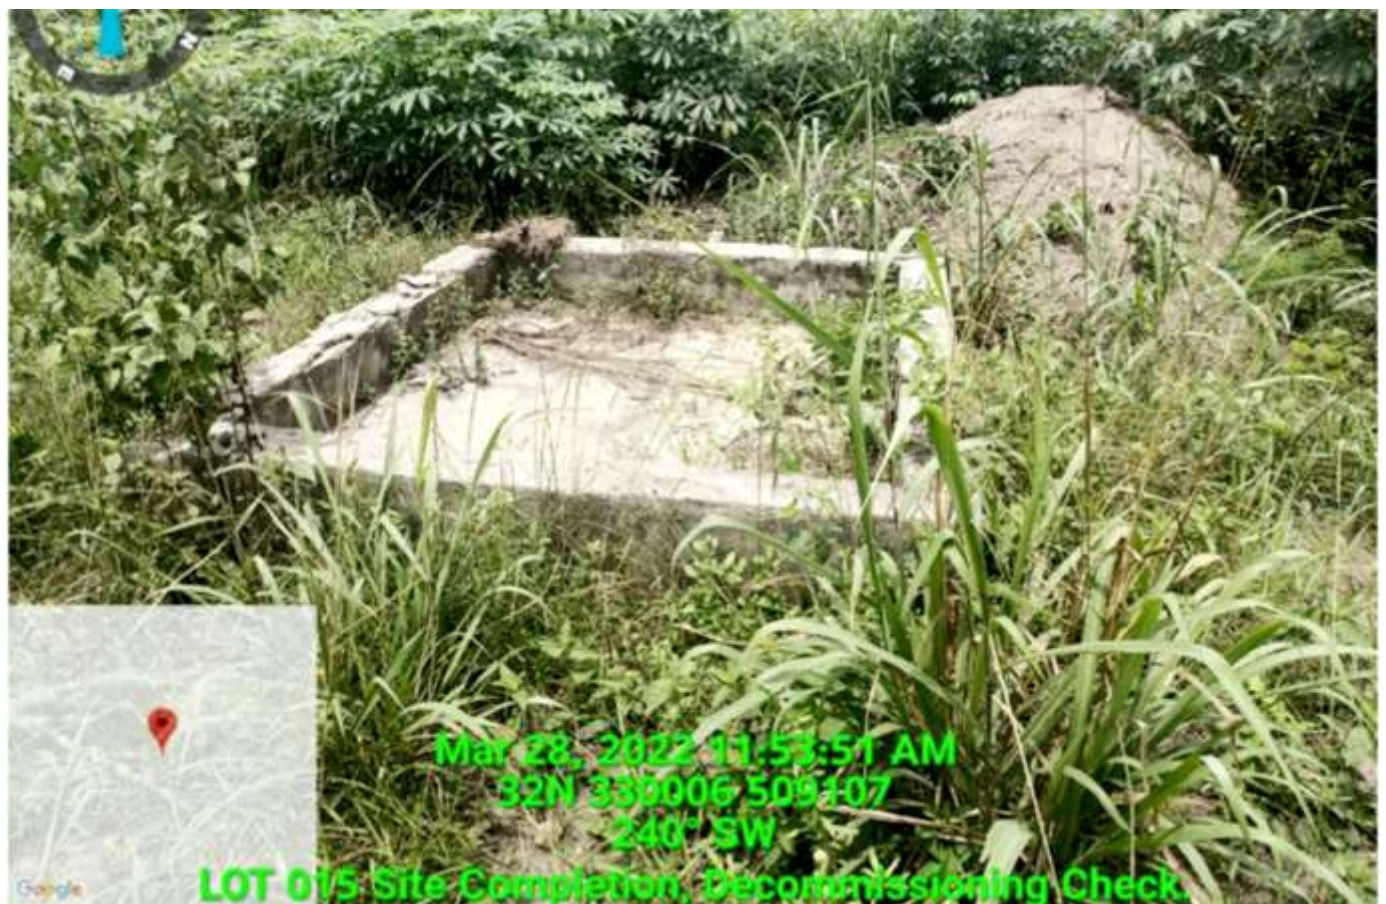
Plate 1.12: Yet to be decommissioned concrete base of the decontamination area at Lot 015 (Wiieborsi -Kpean, Khana L.G.A).

**It is important to note that after the completion of remediation works, and the decommissioning of site facilities, the sites are returned (handed over) to the Communities for their original and intended uses as applicable. Hence, proper decommissioning of site facilities, good housekeeping and proper grading/landscaping of the backfilled area are all required.**
