FEDERAL MINISTRY OF ENVIRONMENT HYDROCARBON POLLUTION REMEDIATION PROJECT (HYPREP) REPORT OF HYPREP ACTIVITIES IN THE MONTH OFJULY 2021

1.0 REMEDIATION WORKS

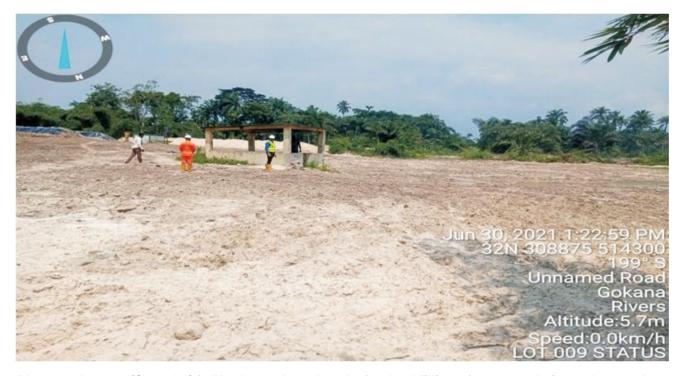
Plate 1.1: Lot 009 (Saanako) in Mogho, Gokana L.G.A after backfilling of excavated pits and general site levelling. (Contractor: ODUN ENVIRONMENTAL LTD).

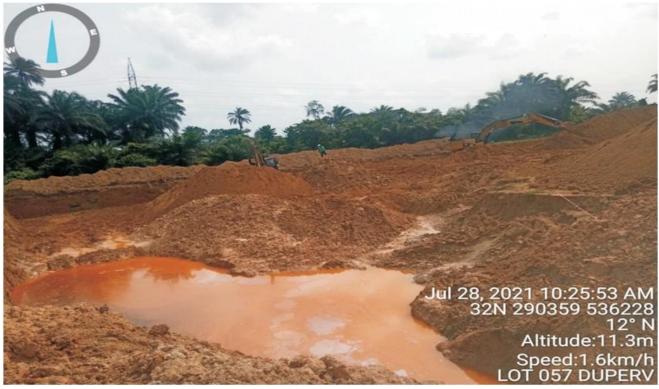
Plate 1.2: Excavation and serial transferring of impacted soil in progress at Lot 057 (New Elelenwa Manifold, Akpajo, Eleme L.G.A). (Remediation Contractor= INTEGRATED CHEMICAL WORKS LTD).

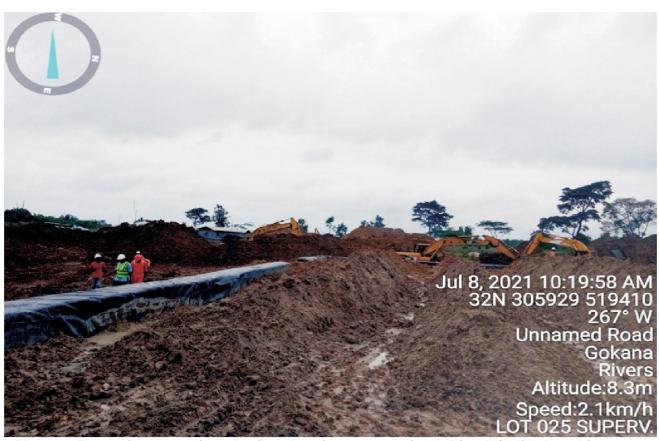
Plate 1.3: Excavation contaminated soil undergoing treatment in the Biocell (solid phase bioreactor cell) at Lot 025 (B. Dere / Gio, Gokana / Tai L.G.A). Remediation Contractor = SUBADOM GLOBAL RESOURCES LTD.

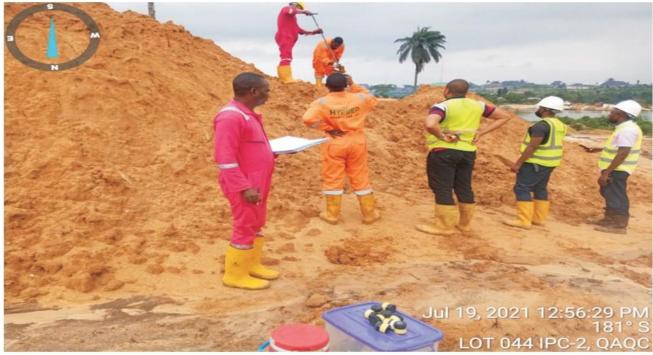
Plate 1.3: Quality Assurance / Quality Control (QA/QC) and Remediation Execution Officers from the Operations Unit of HYPREP collecting QAQC Monitoring Samples from treated soil volumes with the Contractor representatives at Lot 044 (Aleto (Ngofa), Eleme L.G.A).

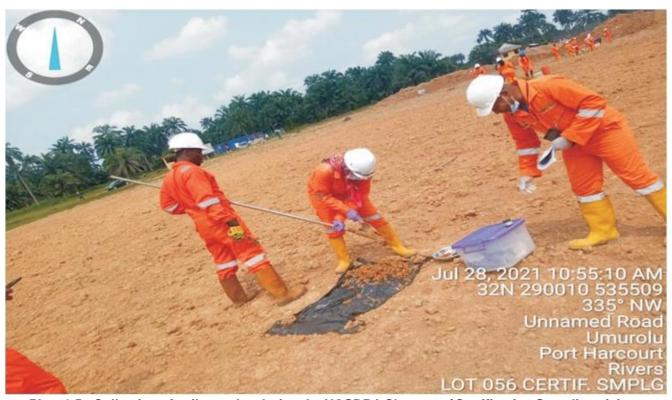
Plate 1.5: Collection of soil samples during the NOSDRA Close-out / Certification Sampling visit to Lot 056 at New Elelenwa Manifold area, Akpajo in Eleme L.G.A). In the background are heaps of soil at neighbouring Lot 057 where excavation and treatment of impacted soil are still on-going.

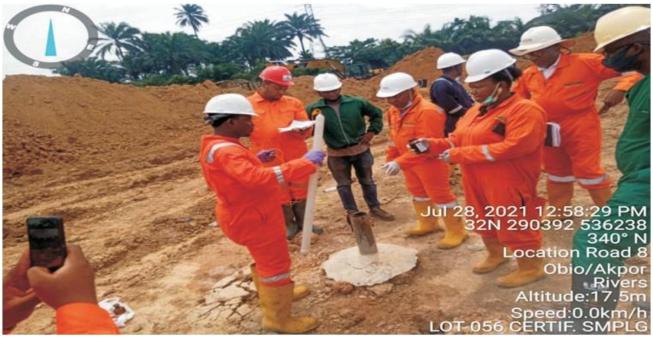
Plate 1.6: Collection of groundwater samples from remediation defensive / monitoring wells during the NOSDRA Close-out / Certification Sampling visit to Lot 056 at New Elelenwa Manifold area, Akpajo in Eleme L.G.A). Contractor: AWA ENGINEERING COMPANY LTD.

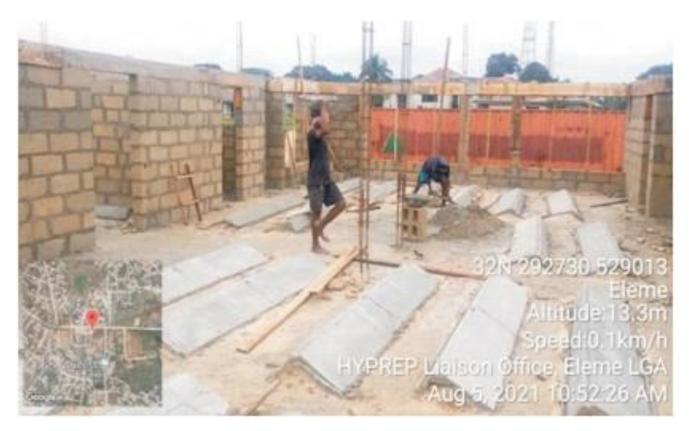
The Contractor, Giolee Global Resources has mobilized to site and has commenced preliminary site activities.

Picture o the External and Internal Building at Eleme

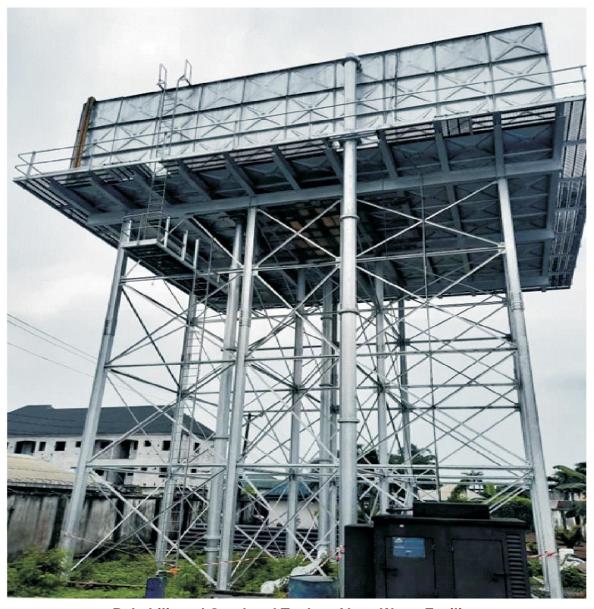
The activities on sites continued as planned. The contractors, within the period, completed the following activities: rehabilitation of the overhead tank, ground tank, aeration tank, two 350kva generator, ozone treatment system, backwash pump, boreholes, service quarter, transformer, and otherfacilities.

Rehabilitated Overhead Tank at Alesa Water Facility

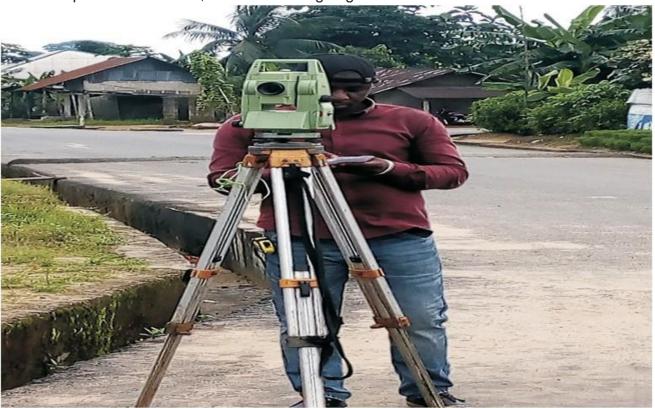
The Contractor has completed the Geophysical surveys and clearing of site in preparation to commence the Site construction activities. He has completed the fencing of Korokoro site. Construction of staff quarter is ongoing at both Korokoro and Nonwa. Borehole drilling has been completed at Korokoro, while work is ongoing at Nonwa.

Survey for Flow Network Analysis at Korokoro
